## STREETLIGHT AUDIT REPORT

# Hosur Road Corridor

6 km stretch · Shoolay Circle to Silk Board · Evening & Night-Time Mobility Assessment

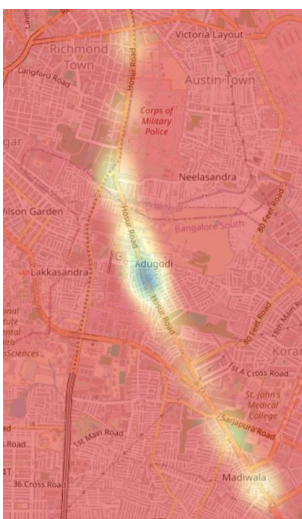
The Kernel Density map below translates individual lux readings into a continuous illumination surface for the corridor. The average illumination level is 67.9 lux (median 57.2 lux), but this average conceals extreme variation — readings range from a near-total-darkness low of 0.015 lux to an over-lit high of 91 lux. The bright core of the density map (white/yellow) sits around the Adugodi – Koramangala stretch, while other segments fade toward red, indicating comparatively weaker illumination.

Kernel Density map — illumination intensity

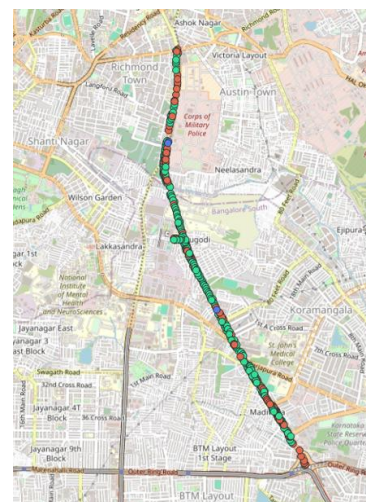
Field-verified fixtures — green: working · red: non-working · blue: broken

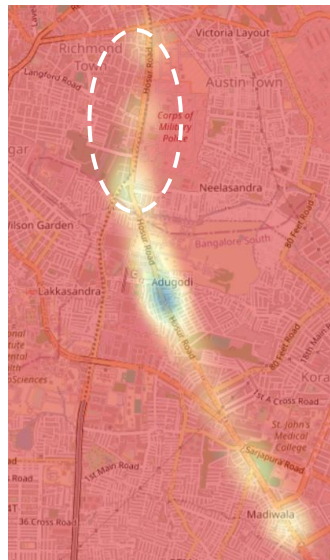
One segment stands out as the corridor's most severe gap not a scattering of failed fixtures, but a continuous stretch with effectively no functioning street or footpath lighting:

*Identified Dark stretch for 1.2 km (Shoolay Circle till Anepalya Junction)*

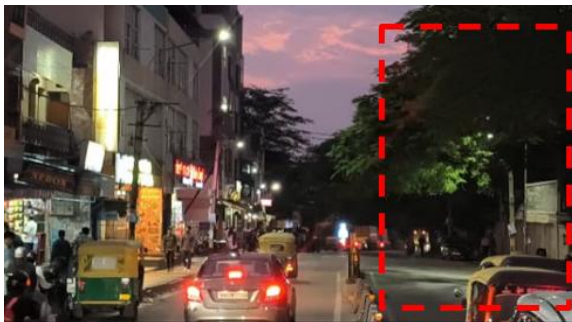
**DARK SPOT**

*Dense tree canopy blocks fixture throw onto the footpath, even where the light itself works.*

**Phase 2** — Then Redesign: Even out illumination levels across the corridor, trim tree canopies that obstruct otherwise-working fixtures, and expand pedestrian-facing coverage before introducing any new infrastructure. Since most existing street lights are mounted on utility poles rather than dedicated street-light poles, future upgrades should progressively shift to dedicated poles placed at uniform intervals, following the spacing and lighting principles recommended in IRC:

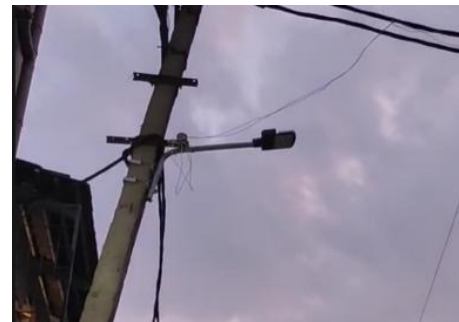
**NON-FUNCTIONAL FIXTURE**

*Dangling, disconnected wiring at the fixture head — counted among the corridor's 98 non-working or broken lights.*

**Phase 1** — Repair Now: Restore all 93 non-working and 5 broken fixtures; carry out structural correction of 32 tilted and 8 damaged poles; and rectify exposed or tangled wiring at fixture bases as an immediate electrical safety measure, prioritising the East side, where the operational rate (64%) trails the West side (76%).

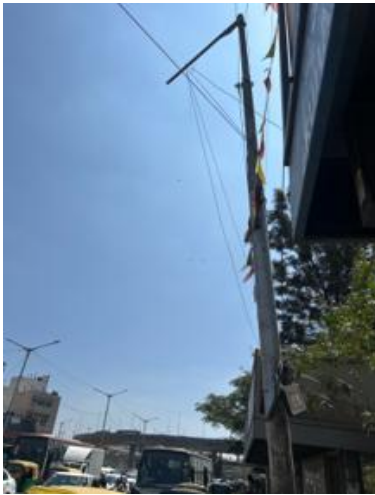
#### STRUCTURAL RISK

*A visibly leaning pole close to traffic and a building edge — one of 32 tilted poles on the corridor.*

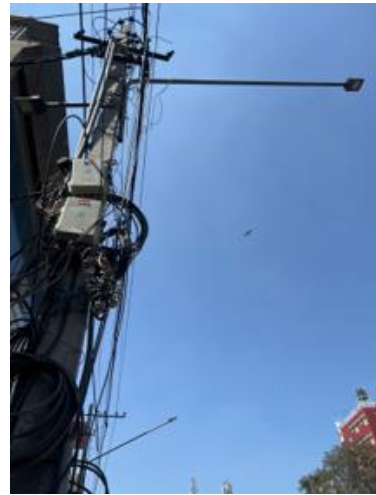
#### SAFETY HAZARD

*Exposed, tangled wiring at a pole base — an electrical safety risk independent of illumination performance.*
