## UNIVERSAL ACCESSIBILITY AUDIT

# Hosur Road Corridor

6 km stretch (12 x 500m chainage segments) · Shoolay Circle to Silk Board · Walkability & Inclusive Mobility Assessment

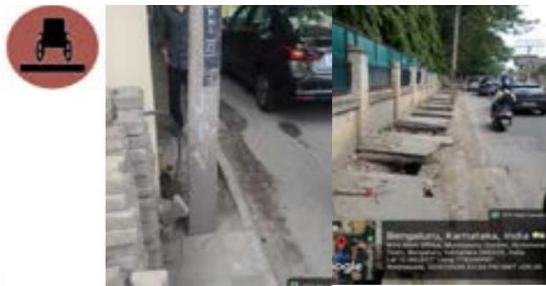
#### FOOTPATH INFRASTRUCTURE

**3.1 Footpath Infrastructure, Kerb and Level Differences:** Narrow and uneven pedestrian walkway with a utility pole obstructing the usable footpath width. Footpath is severely damaged with open drainage and broken pavement, creating significant level differences and reducing pedestrian accessibility.

Figure 3: A utility pole and open drainage narrow the usable footpath to almost nothing, forcing pedestrians into the carriageway.

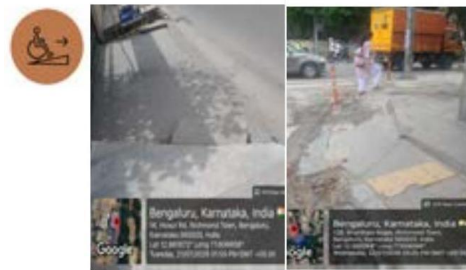
#### RAMPS & TRANSITIONS

**3.2 Ramps and Transitions:** Ramp/transition is provided at the road edge, but the surface is uneven and does not provide a smooth accessible connection. Tactile paving is present near the transition; however, the surrounding surface is damaged and the accessible route is interrupted.

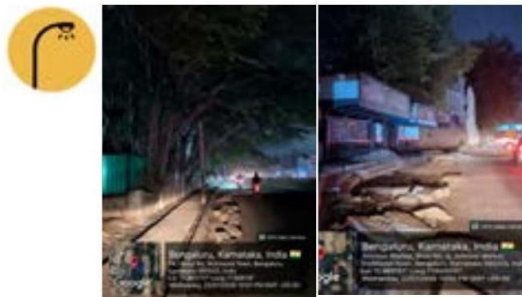
#### LIGHTING CONDITIONS

**3.9 Lighting Conditions:** Pedestrian edge and footpath are poorly illuminated at night, with heavy tree cover further reducing visibility. Night-time visibility is inadequate along the damaged footpath, creating potential safety concerns for pedestrians.

Figure 5: Heavy tree cover and missing pedestrian-scale fixtures leave the footpath poorly lit and unsafe to use after dark.

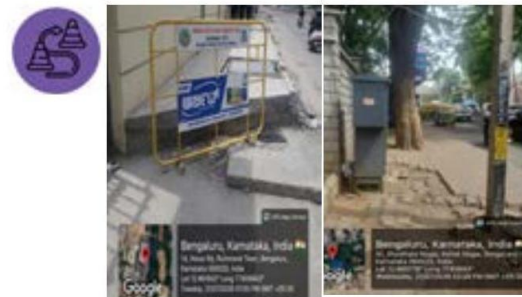
#### BARRIERS & ENCROACHMENTS

**3.10 Barriers, Obstructions and Encroachments:** Temporary barricades obstruct the footpath and force pedestrians to negotiate around the obstruction. Tree roots, broken paving and utility infrastructure obstruct the pedestrian pathway and significantly reduce its accessibility.

Figure 6: A temporary barricade forces pedestrians off the footpath entirely, while utility boxes and tree roots obstruct the path beyond it.
