IRR Street: Standstill to Active

A Comprehensive & Collaborative Approach to Sustainable Mobility

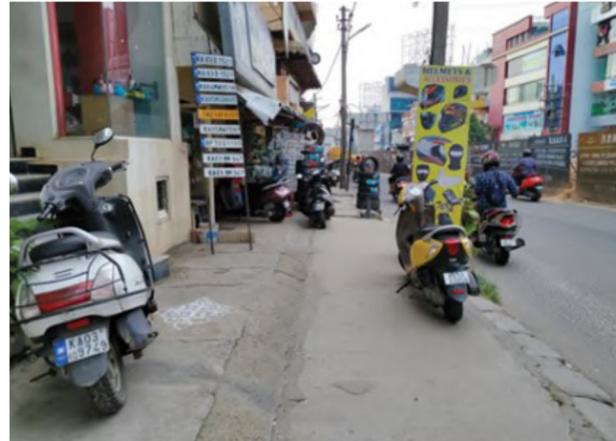
Footpath Obstructions

Footpaths are an obstacle course with construction debris, garbage, vehicles parking, and shop standees blocking the walk, forcing pedestrians onto the roads.

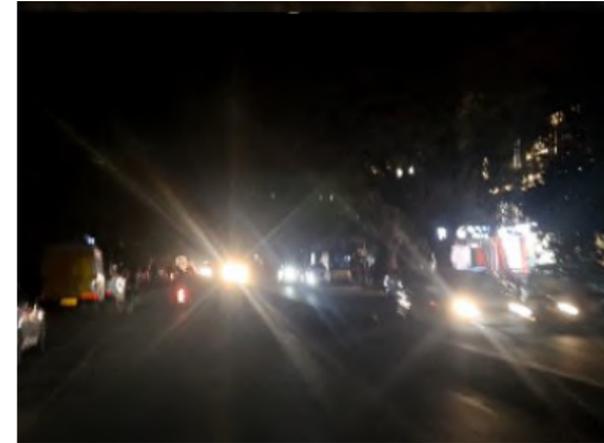
Street Lighting

Damaged lamps and missing poles result in pitch dark patches, risking road crashes and vulnerability to theft and crimes.

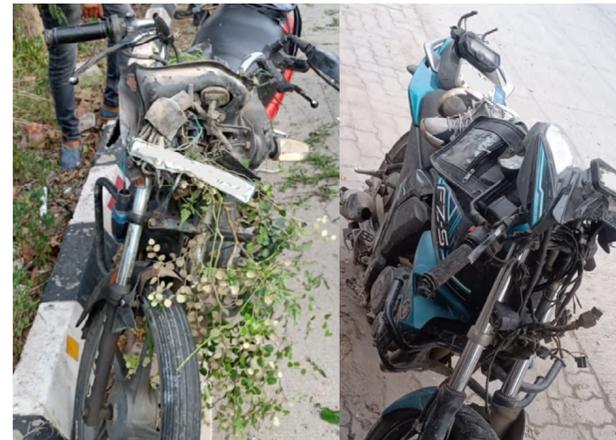
Fatal Crashes from Speeding

Roads without traffic calming lead to speeding and fatal crashes. Missing pedestrian crossings and road markings pose road safety risks.

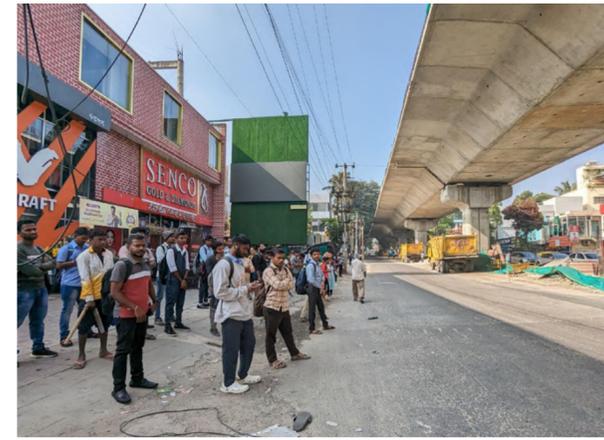
Buses and Bus stops Conditions

Buses sometimes arrive at 15 minute intervals. Many bus waiting shelters lack basic amenities and information, while some are missing altogether.

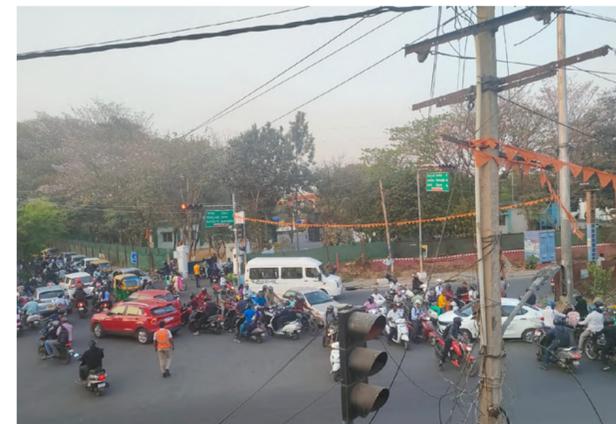
Traffic congestion

Several hours are lost due to traffic congestion, emphasizing the need for more efficient public transportation. Garbage and debris dumped alongside add to it.

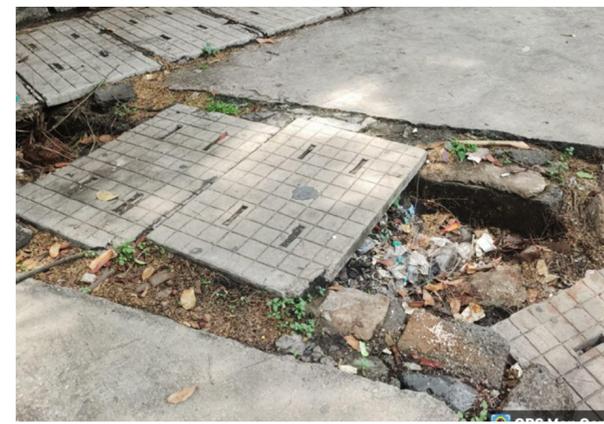
Drainage Problems

Missing drainage inlets and garbage in SWDs cause urban flooding and safety risks. Open drain covers during construction add to the danger.

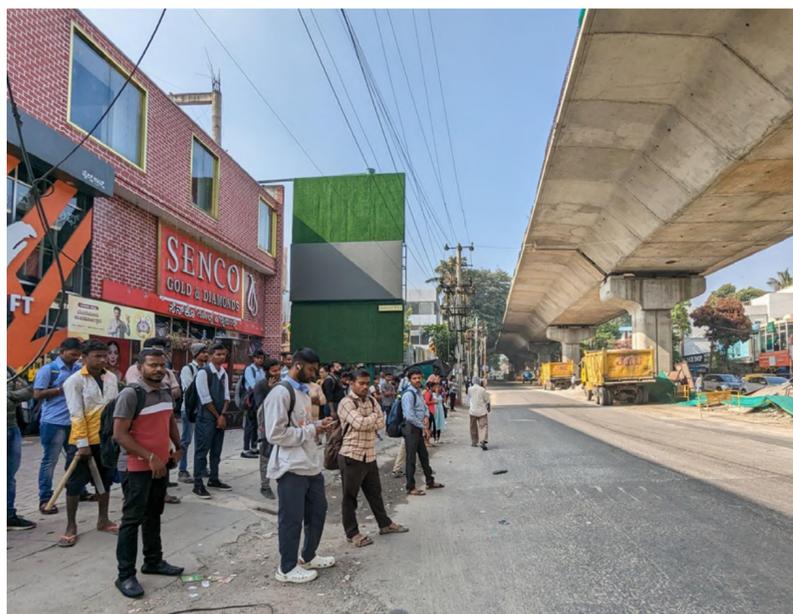
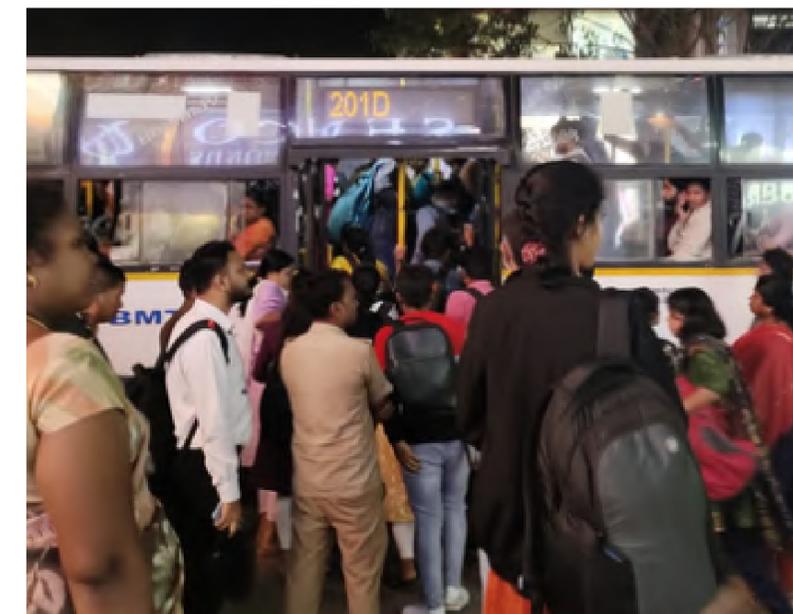
Missing bus waiting shalter at Sony Signal (towards Koramangala). Headway of 15 minutes observed at times during day and night leading to a large number of people standing and waiting, and buses getting overcrowded.

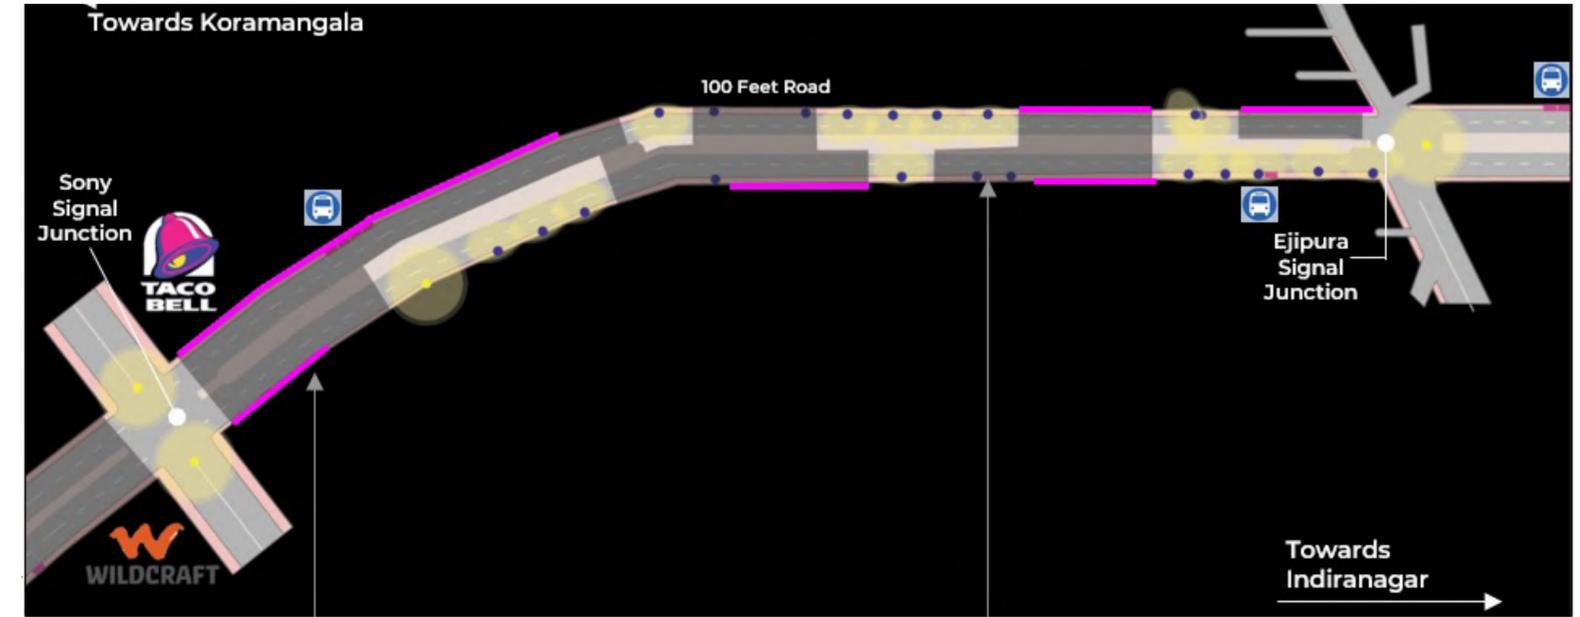
No streetlight zone

Streetlight are not functional

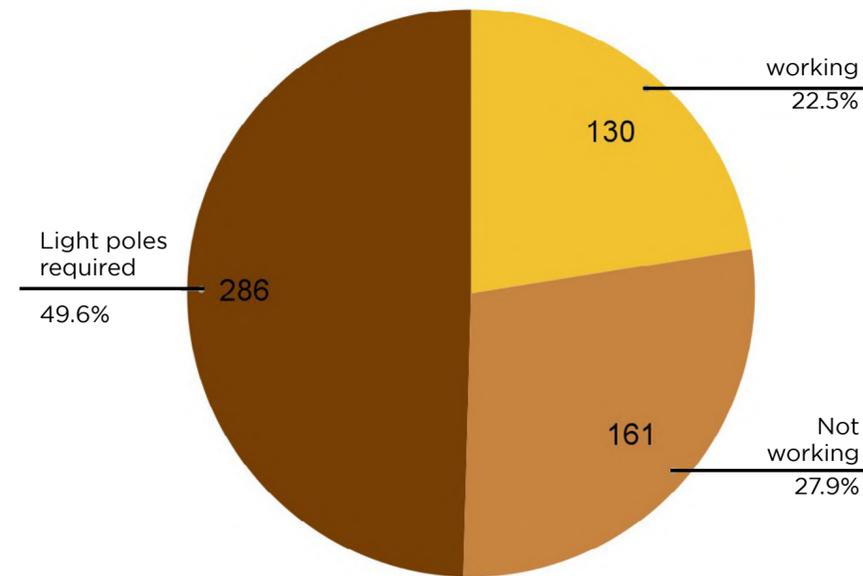
*286 + pedestrian light poles absent for 4.3km from Domlur flyover till Ejipura signal

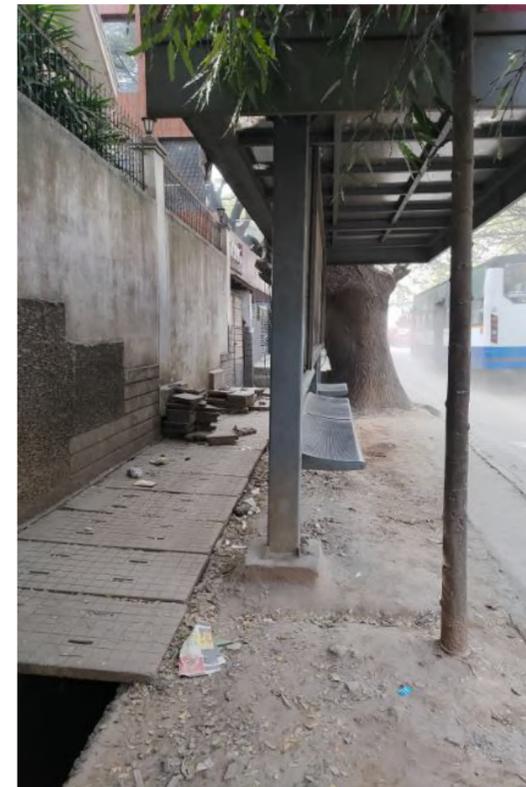
Koramangala water tank bus stop (towards Koramangala) - broken footpath and open drain.

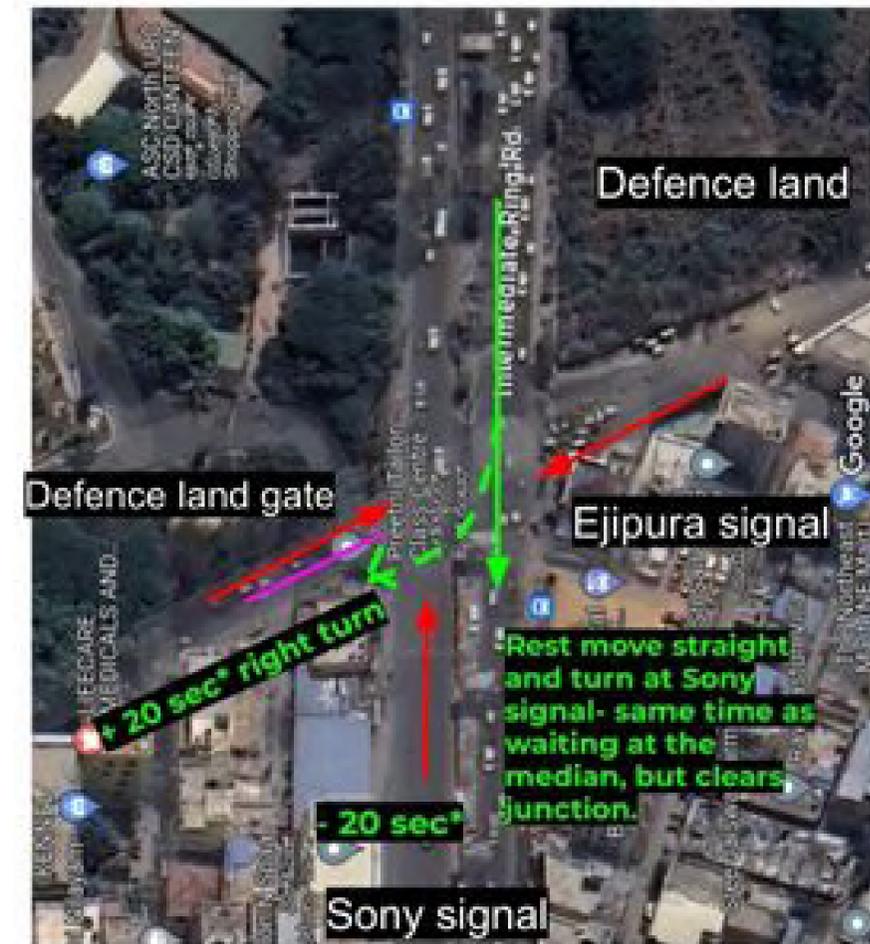
Recommendation for signal modification at Ejipura Junction

- ↑ Vehicles waiting at red signal
 - ↑ Vehicles moving at green signal
 - | A thin barricade to stop spillover to opposite lane.
- North ←
- *20 sec is indicative only. Time to be determined by BTP.

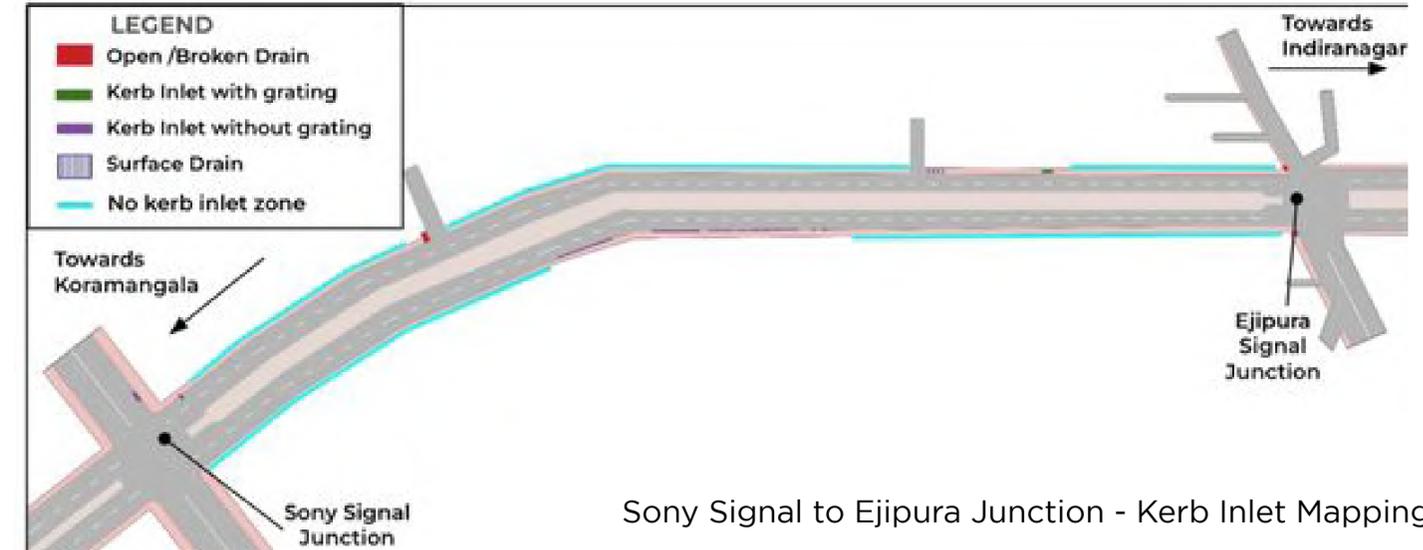
Sony Signal to Ejipura Junction - Kerb Inlet Mapping

Kerb inlets to stormwater drains were largely found to be missing in the stretch, especially in Koramangala, which is prone to urban flooding. Surface drains tend to get easily clogged with litter and silt. Similar clogging in the open stormwater drains (SWDs) and kerb inlets hampers effective water flow. SWDs left open during repair or desilting pose serious risk to life of pedestrians. BBMP Project Central 9 has taken note of this and the contractor was asked to:

- close the drains responsibly before leaving site
- shoulder drains were asked to be constructed at every 5m-7m, instead of 30m that was being constructed on site.
- leveling of pavers and 1% slope to drain water from footpaths.
