### **IMPACT**

### **IMPACT ON GROUND**

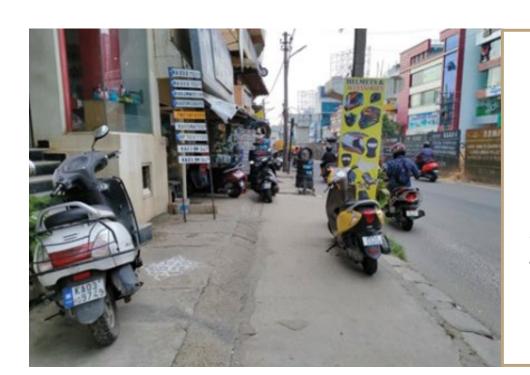
### **Footpath Obstructions**

Footpaths are an obstacle course with construction debris, garbage, vehicles parking, and shop standees blocking the walk, forcing pedestrians onto the roads.

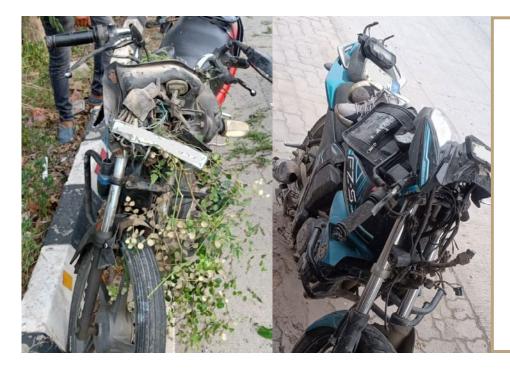
# Fatal Crashes from Overspeeding

Roads without traffic calming lead to overspeeding and fatal crashes. Missing pedestrian crossings and road markings pose road safety risks.

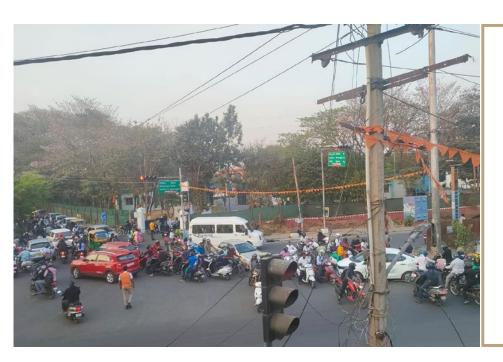
### **Traffic congestion**

Several hours are lost due to traffic congestion, emphasizing the need for more efficient public transportation. Garbage and debris dumped alongside add to it.

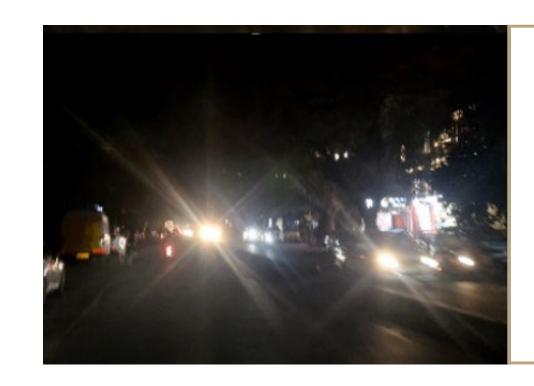
### **Street Lighting**

Damaged lamps and missing poles result in pitch dark patches, risking road crashes and vulnerability to theft and crimes.

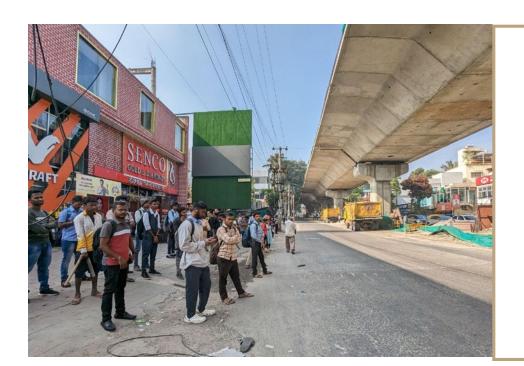
### **Buses and Bus stops Conditions**

Buses sometimes arrived at 15 minute intervals. Many bus waiting shelters lack basic amenities and information, while some are missing altogether.

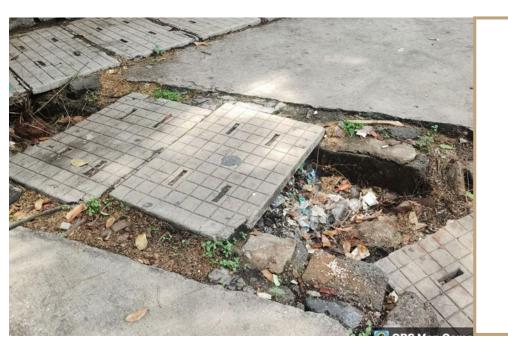
### **Drainage Problems**

Missing drainage inlets and garbage in SWDs cause urban flooding and safety risks. Open drain covers during construction add to the danger.

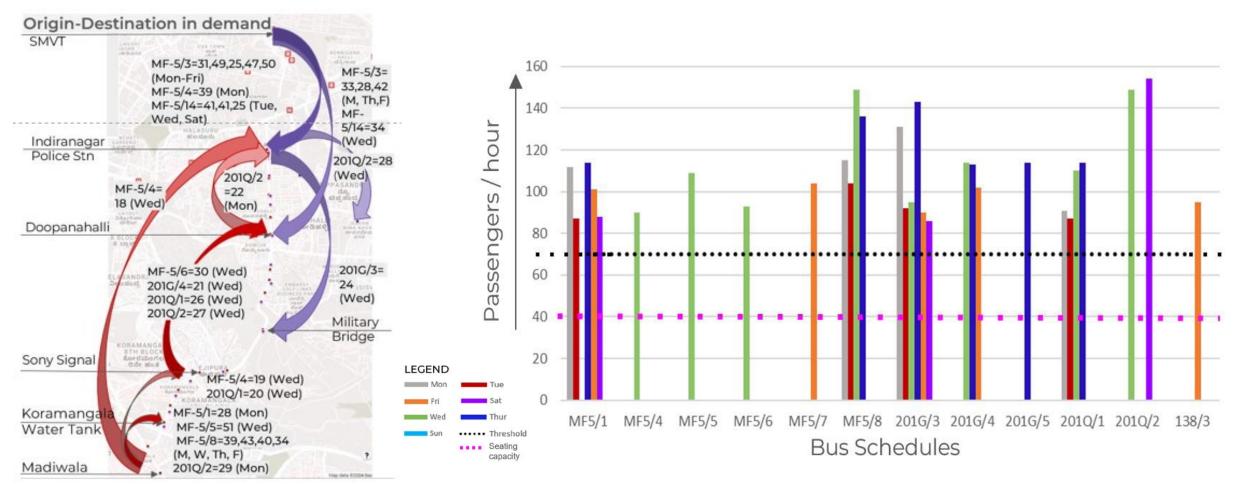
8-9am Hourly Origin-destination demand mapped.

Passengers/ bus towards Indiranagar at 8- 9am in a typical week. Over 140 passengers approx. in some buses at peak hours.

The gap in bus supply and demand was inferred by analysing 1.1 Lakh+ bus ticket data, origin-destination demand and conducting bus frequency vs. occupancy surveys on-ground. BMTC has added 9 buses and 58 trips to the MF5 route, which was the most in demand, based on the study.

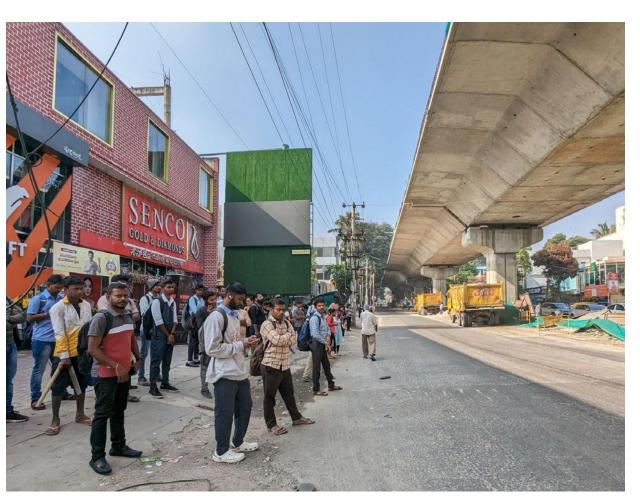
Missing bus waiting shalter at Sony Signal (towards Koramangala). Headway of 15 minutes observed at times during day and night leading to a large number of people standing and waiting, and buses getting overcrowded.

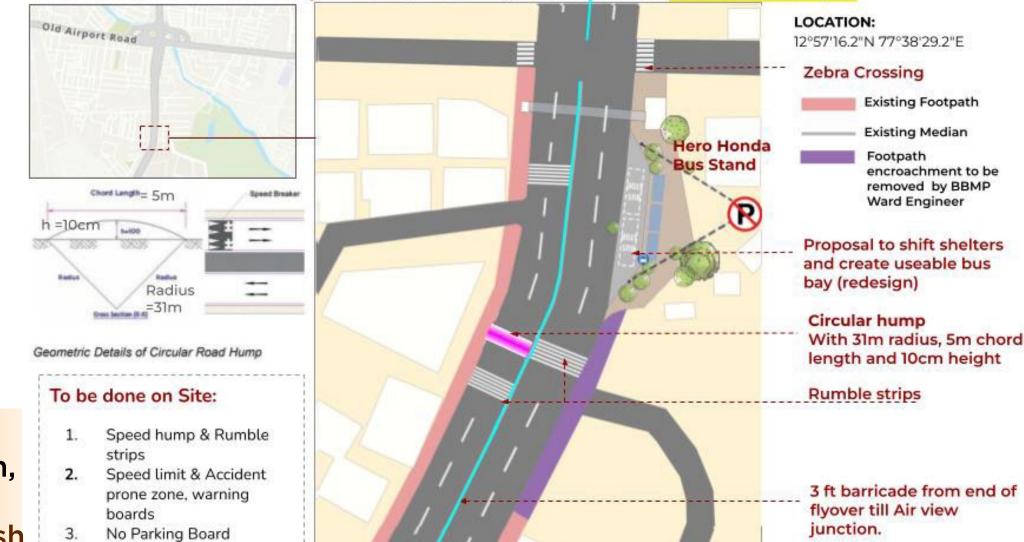
Hero Honda Bus Stop - Traffic Calming Measures for Death Black spot

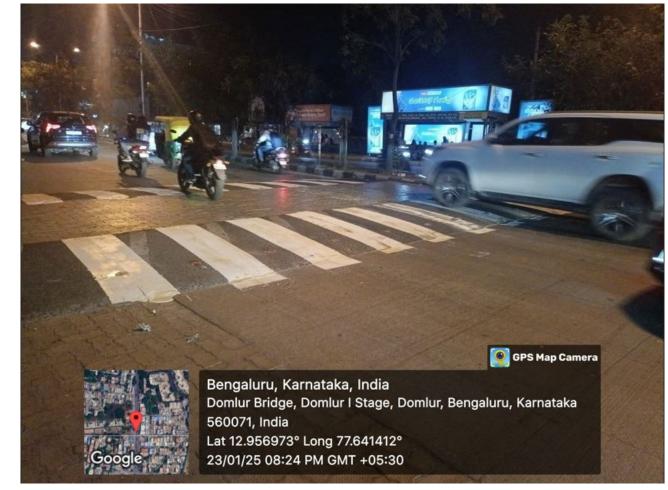
Raised pedestrian crossing (HRPCs) executed near TATA motors, Domlur Bridge bus stop.

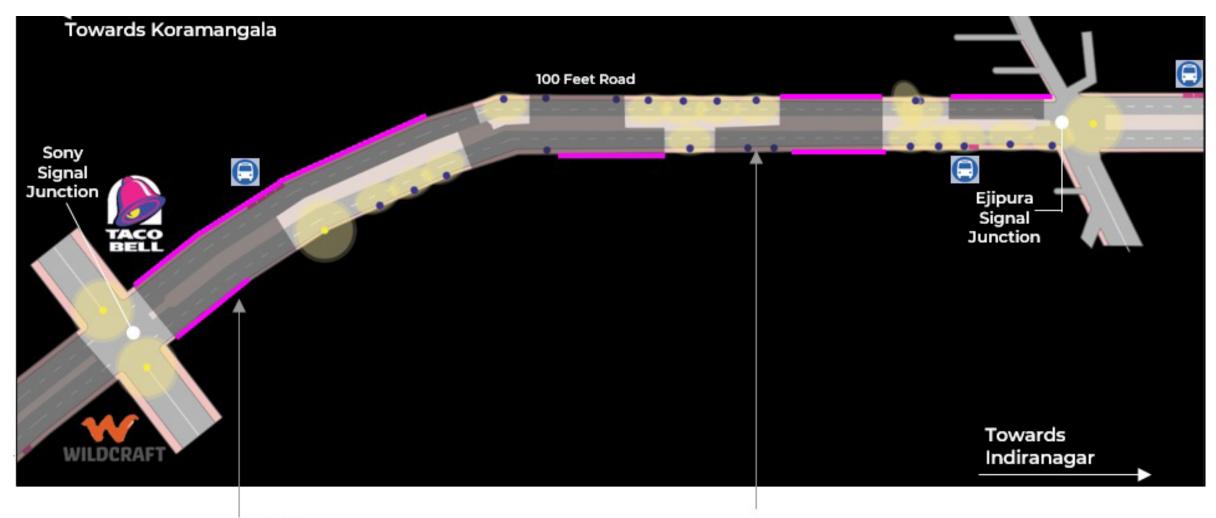
No streetlight zone

\*286 + pedestrian light poles absent for 4.3km from Domlur flyover till Ejipura signal

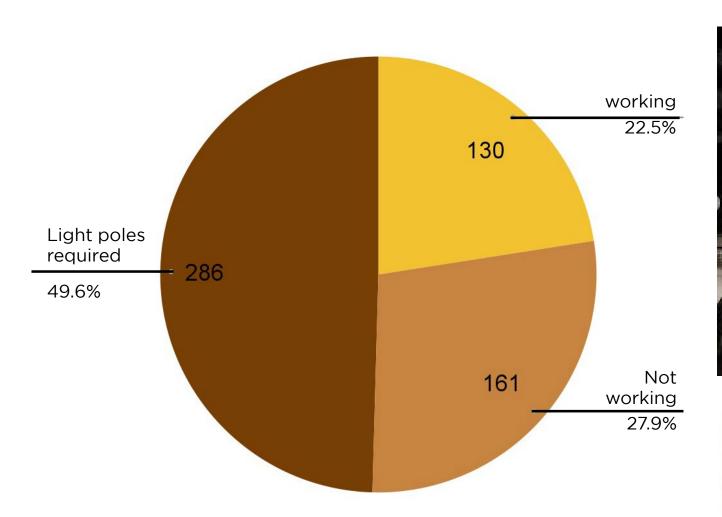
Streetlight are not functional

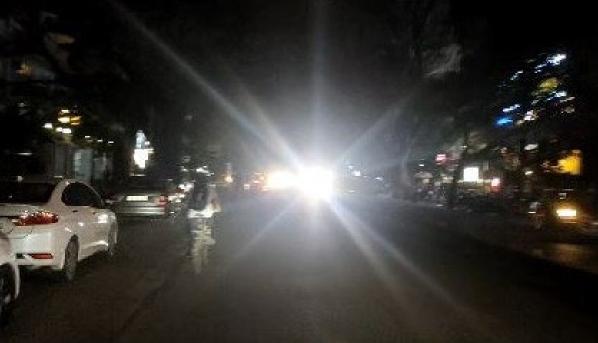
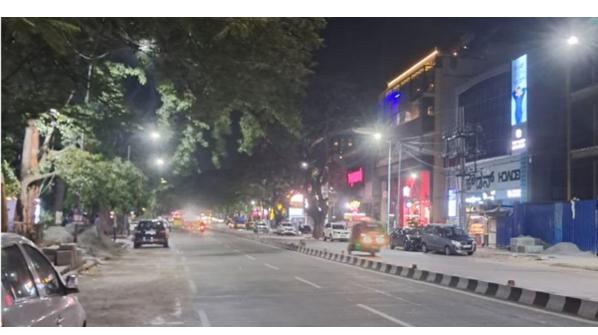
Streetlights electrified from Indiranagar 16th main to Domlur flyover on both RHS, LHS & pedestrian lights.

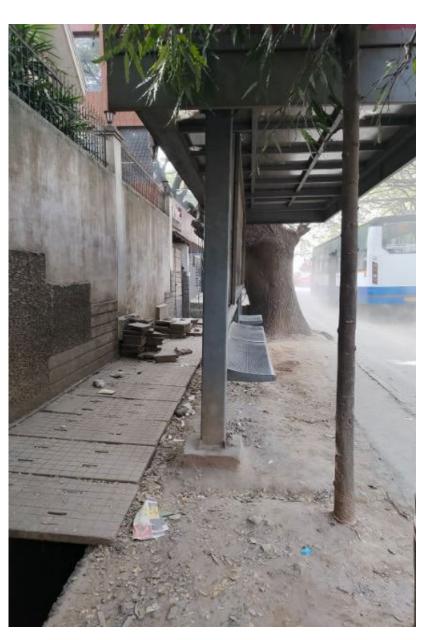
Koramangala water tank bus stop (towards Koramangala) - broken footpath and open drain.

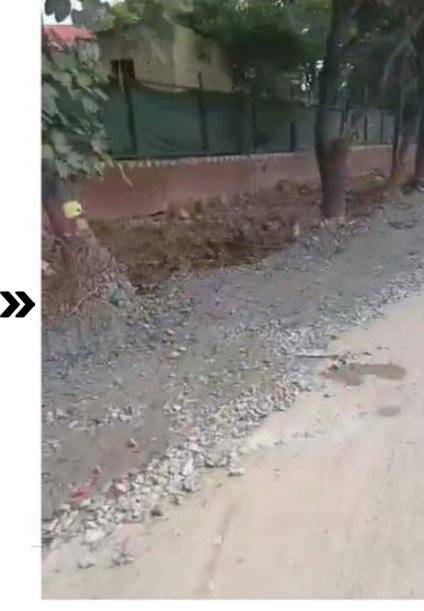
Implementation of a temporary walkway and 10 temporary lights near Ejipura bus stop towards Indiranagar, after our persistent advocacy.

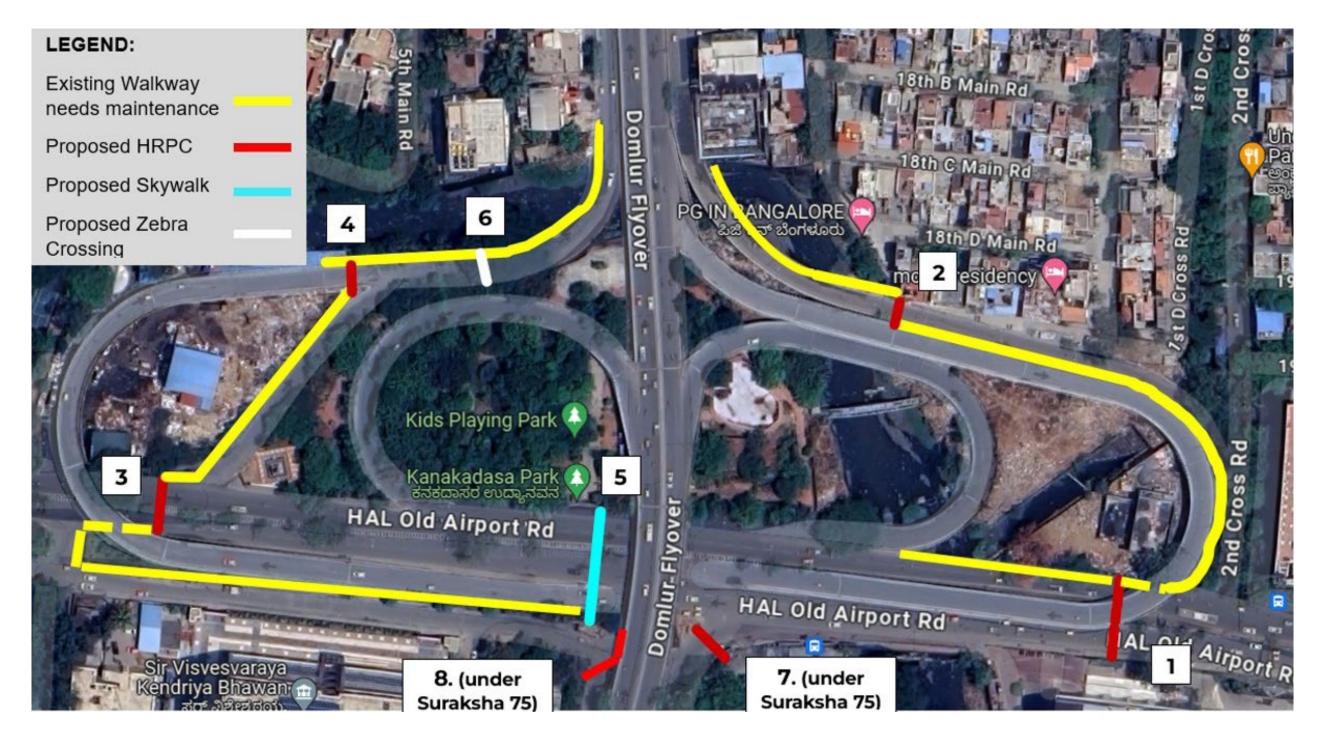
Pedestrian access proposal -key map.

The Domlur Flyover was constructed to streamline traffic, but unfortunately has not considered any accessibility for pedestrians. Footpaths along the flyover are not maintained and remain disconnected, making it exceedingly difficult for pedestrians. They end up crossing busy roads with fast-moving vehicles, risking their safety.

To improve safety and accessibility, we have proposed 6 interventions that will help utilise existing pedestrian infrastructure along the flyover and create new ones for safe pedestrian access. 2 other interventions will be taken up under Suraksha 75.

A joint site inspection was organized by B.PAC with DCP Traffic East, Jeevanbhima Nagar Traffic Inspector, BBMP TEC East and MayaPraxis. The 6 interventions were agreed upon at the site by TEC and BTP. Letters have been sent from BTP to BBMP TEC requesting the installation of the same.

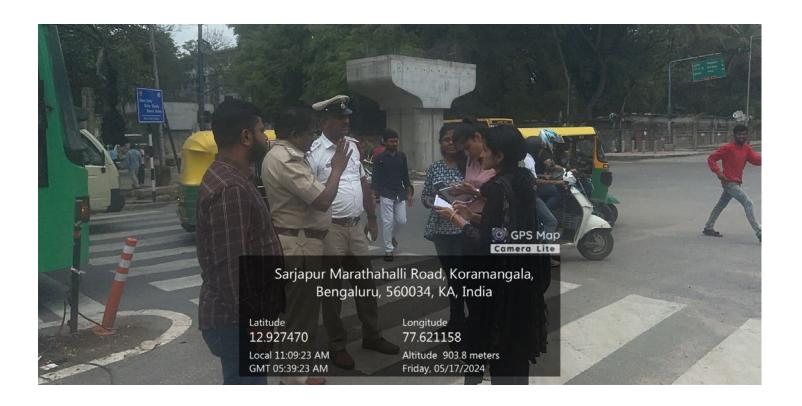
Vehicle count at Ejipura signal at 6pm

Traffic signal audits were conducted at four junctions: Ejipura, Sony World, Koramangala Water Tank and Indiranagar 12th main junctions. Patterns of vehicle and pedestrian movement were observed for each signal cycle for a duration of 30 minutes.

For Ejipura Signal and Sony World signal, vehicle count with respect to signal cycle and signal timing for pedestrians were observed., and recommendations shared.

6:00 PM		Timing	Bike	Car	Auto	Van	Bus	Truck	Bicycle	Total motor vehicles
Towards Koramangala (straight)	Red	66s								
	Green	209s	145	94	35	2	1	11		288
Towards Ejipura Main Road (right)	Red									
	Green	30	37	7	6	-	1.0	14	-	50
Towards Defence Gate	Green	30s								338
Right of Bar	Green	33s								
Towards Indiranagar (IRR)	Green	214s

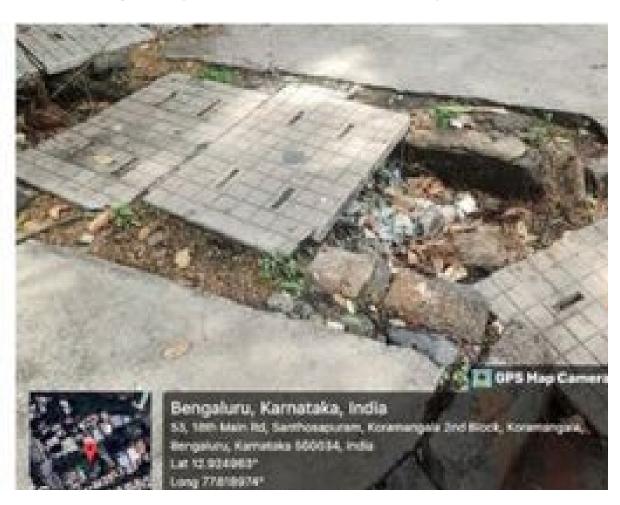
Kerb inlets to stormwater drains were largely found to be missing in the stretch, especially in Koramangala, which is prone to urban flooding. Surface drains tend to get easily clogged with litter and silt. Similar clogging in the open stormwater drains (SWDs) and kerb inlets hampers effective water flow. SWDs left open during repair or desilting pose serious risk to life of pedestrians. BBMP Project Central 9 has taken note of this and the contractor was asked to:

- close the drains responsibly before leaving site
- shoulder drains were asked to be constructed at every 5m-7m, instead of 30m that was being constructed on site.
- leveling of pavers and 1% slope to drain water from footpaths.

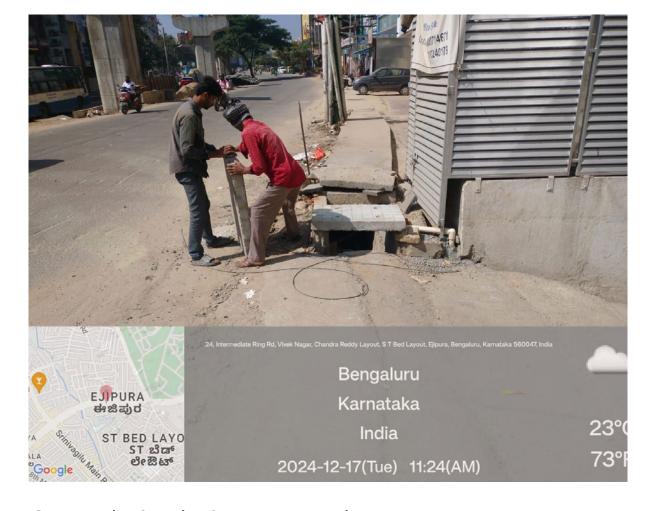
Open drains being covered.
