# Street: Standstill to Active

A Comprehensive & Collaborative Approach to Sustainable Mobility

Improving Bus reliability, Walkability & Road Safety  
7.5km of Inner Ring Road (IRR)

July 2025

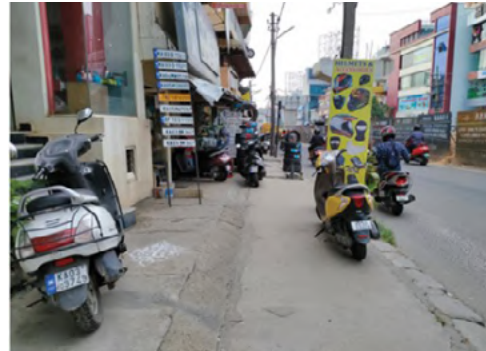
Forces pedestrians to walk on the roads, increasing the risk of road crashes.

Image: Vehicles and standees creating an obstacle course on the footpaths of Kormangala 100ft.

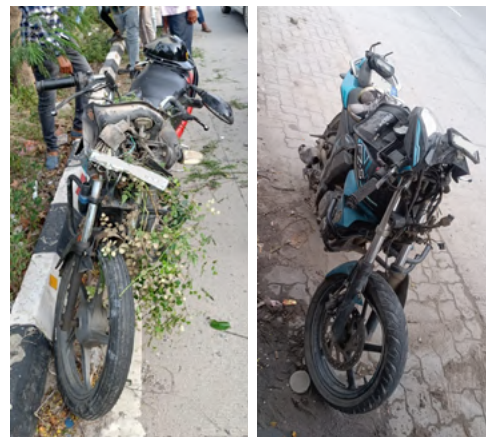
- Increased instances of fatal crashes due to overspeeding.
- Missing pedestrian crossings and unclear road markings further exacerbate safety risks.

Image: Two wheelers crashed on to the curve of the defence land stretch on IRR.

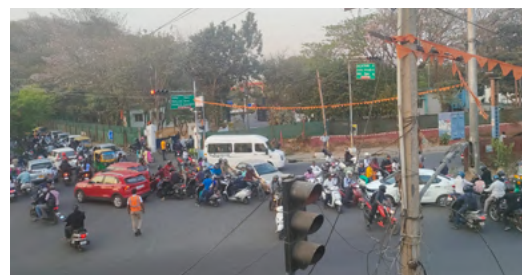
- Wastes hours of commuter time, causing frustration, increasing the accidents risk.
- Financial impact: 13% of commuter income is lost due to health issues like air pollution, which leads to respiratory diseases (eg: chronic cough, asthma).

Image: Severe traffic congestion and gridlock at Ejipura signal at 6pm on a weekday.

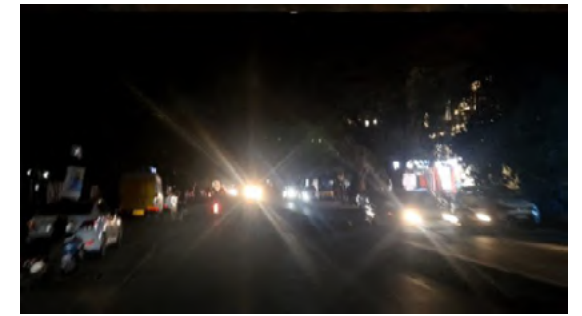
Damaged or missing streetlights result in dark patches along the road, particularly at night.

- Creates safety concerns for pedestrians and drivers.
- Increases the risk of theft, accidents, and other crimes.

Image: Non functional street lights at Indiranagar 100ft.

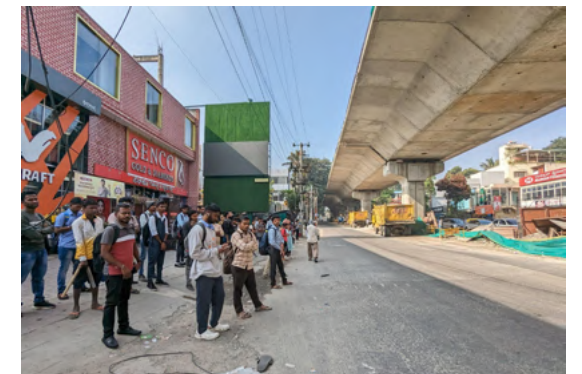
Public transport faces several issues like Buses arrive at intervals of up to 15 minutes, despite high passenger flow. Bus shelters along the IRR often lack basic amenities or are completely missing.

- Citizens resort to private vehicles, increasing traffic congestion
- Leads to overcrowding in buses upon arrival.

Image: People waiting at Sony Signal bus stop (towards Koramangala). Irregularities in bus frequencies with 15 minute intervals at time. Bus waiting shelter is missing here.

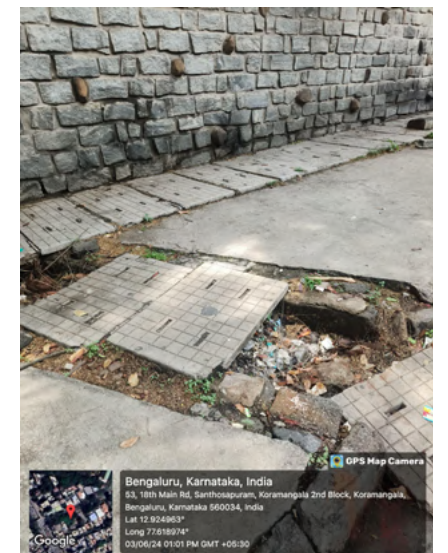
Image: Shoulder drain blocked with garbage at Koramangala 100ft.

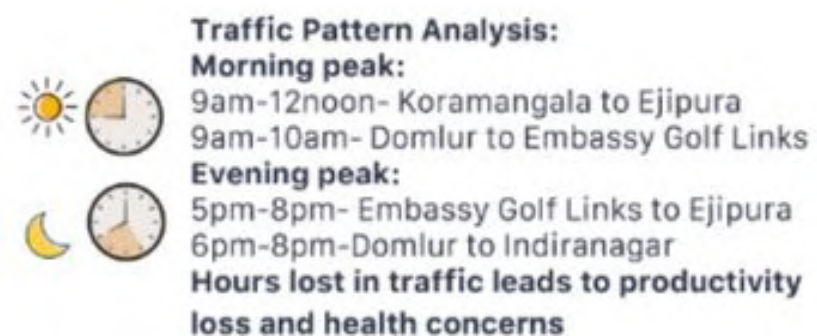
Figure: Congestion Graph From KFC Junction to Koramangala Water Tank. From 5th November To 11th November (Sunday-Saturday). Source: Bengaluru Traffic Police.

**Observation:** Wednesdays seem to have the highest traffic congestion with queue length going upto 2.6km at 19:00.

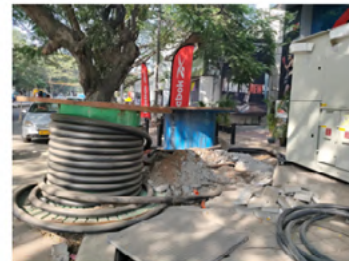
Pipes and debris @ Indiranagar 100 ft

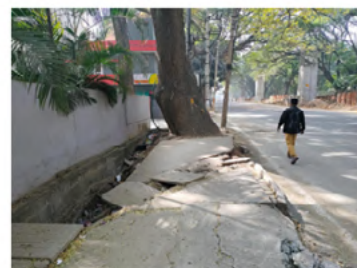
Broken slabs, pavers and open drains in Koramangala

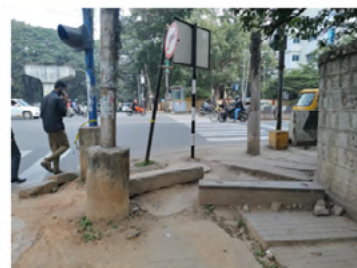
Condition of footpath at junctions

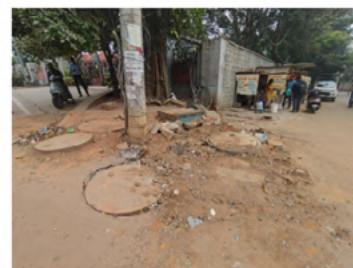
Manholes at junction

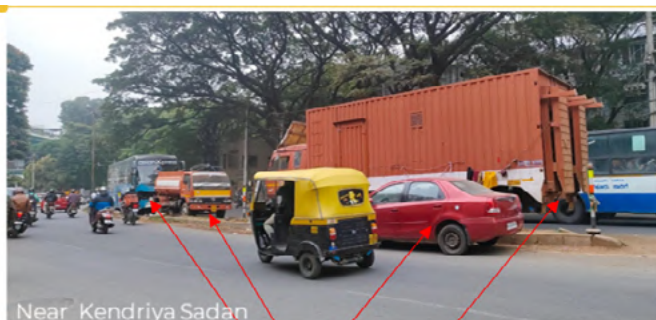
Vehicles parked near/on the median for days.

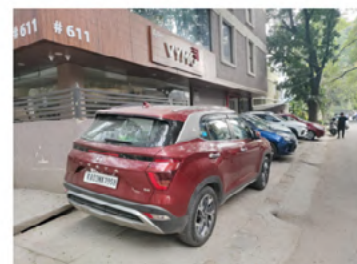
Vehicles parked on footpath

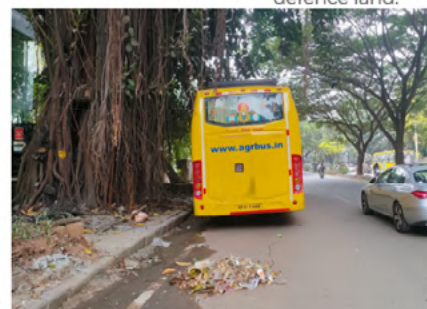
Buses parked on road next to obstructed/broken footpaths, results in pedestrians walking at centre of the road, posing safety risk.

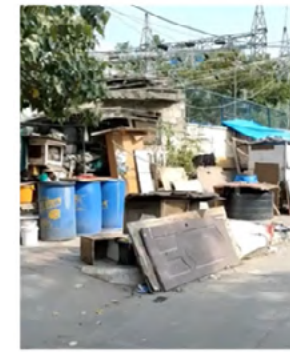
Obstruction on Embassy Golf links footpath

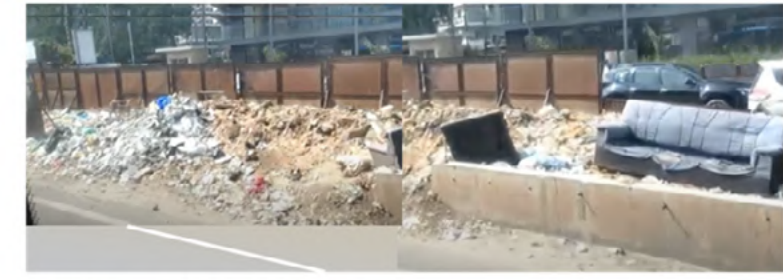
Garbage dumped below Ejipura Flyover.

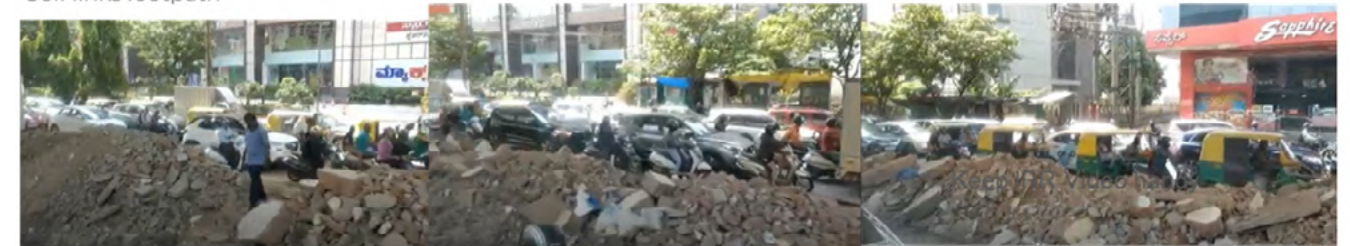
Debris below Ejipura Flyover

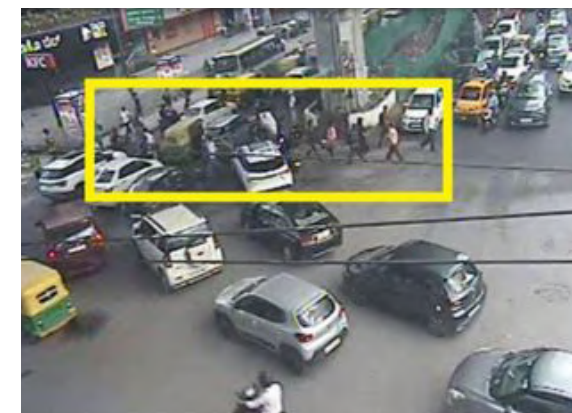
Image above: Unsafe crossing: Missing pedestrian crossing and median refuge island. Source: BTP CCTV.

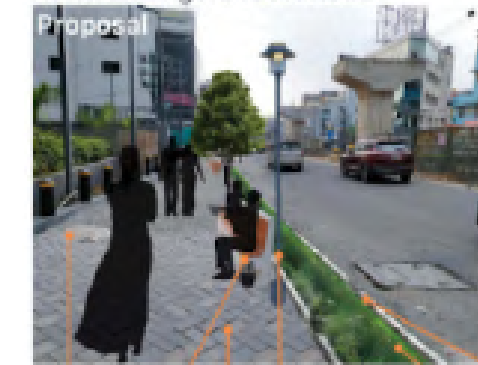
Image to right: Proposed interventions to holistically improve footpath at Koramangala 100ft.

- Footpaths: Walkable**
- Evenly levelled footpaths
  - Obstructions free
  - Surveillance and penalisation
  - Utilities and stormwater network to be organized.

**Medians: Debris and litter free**

- Seating
- Solar white LED full cut off fixtures
- Bioswale
- Kerb inlet
- Utility Manhole
- Obstruction free, levelled footpath, accessible to all.

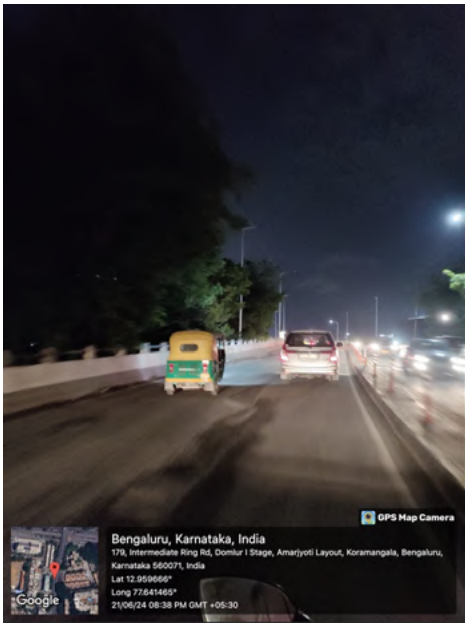
Image: Domlur flyover had only 5 functional lamps above it.

**Observations:**  
Few missing poles and non-functional Median lamps. The wide footpaths are slightly dark and hidden in some stretches.

**Impact:**  
Non-functional lamps above Domlur flyover have been replaced with functional ones, lighting up the stretch.

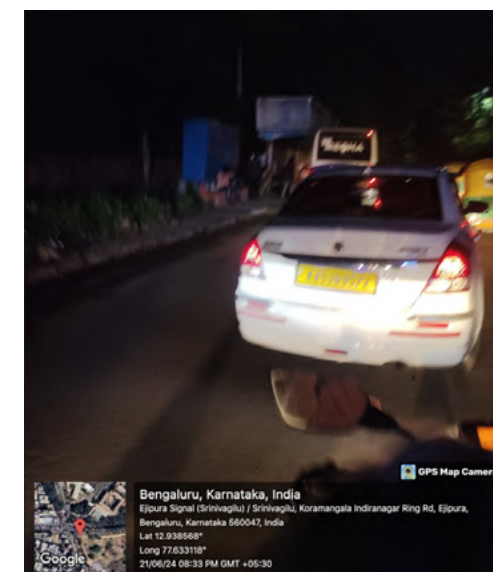
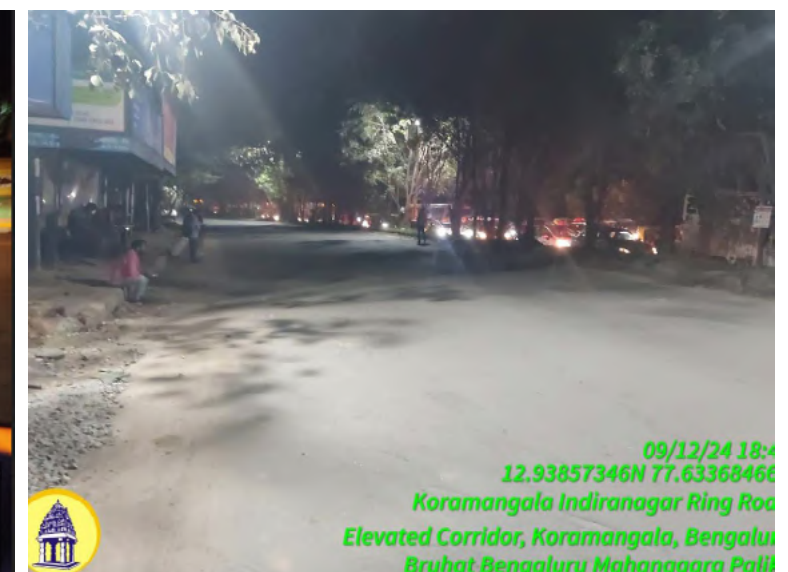
Image: The access to Ejipura Bus stop and shelter was pitch dark earlier. The stretch until Ejipura Bus stop is installed with temporary lamps by the flyover contractor, upon B.PAC advocacy. Thanks to Chief Secretary. & BBMP Project Central for taking action.

- 10** + street lights electrified from Indiranagar 16th main to Domlur flyover.
- 15** Lamps above the Domlur flyover were made functional after our streetlight audit was submitted.
- 10** New LEDs are added in Koramangala to existing RCC poles.
- 10** Temporary street lights added on footpath leading to Ejipura Bus Stop towards Indiranagar.

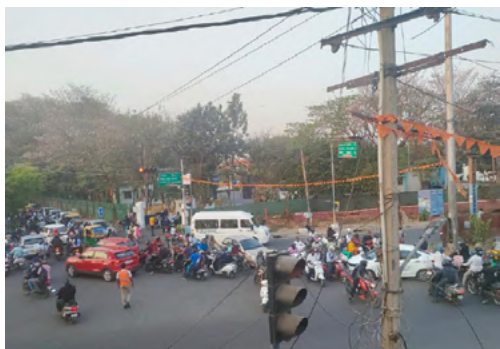
Image: Traffic management issue at Ejipura Junction.

To alleviate this, it's recommended to introduce a right turn signal for the initial seconds towards Ejipura Main Road. These seconds can be taken from the less congested direction towards Domlur during the evening peak.

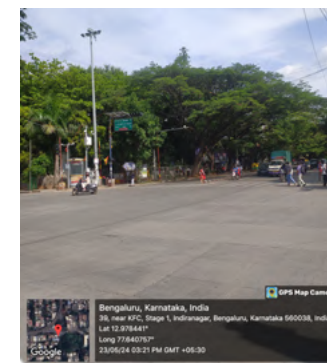
Image: Zebra crossings exist, but were slowly fading. Median is not very visible at night.

Proposed zebra crossings to be marked on the median of all roads and the installation of a hazard board on Indiranagar Main Road for pedestrians by providing designated crossing points and alerting drivers.

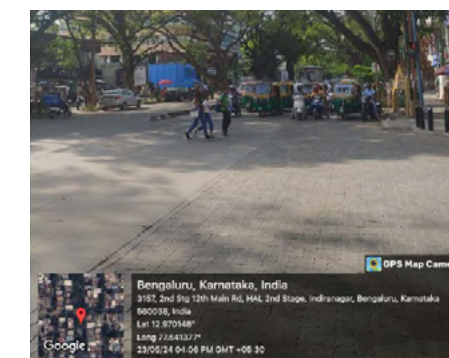
Image: People crossing at the junction. Missing zebra crossing.

1. Zebra Crossing
2. Stop Lines
3. Hazard Board

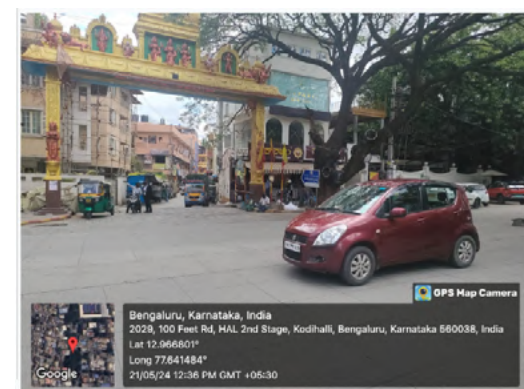
Image: The junction has no pedestrian crossing, and heavy pedestrian movement across.

Zebra crossings, rumble strips, and lane markings have been proposed at 15th Main Road junction to control traffic speed, and ensure orderly vehicle movement.

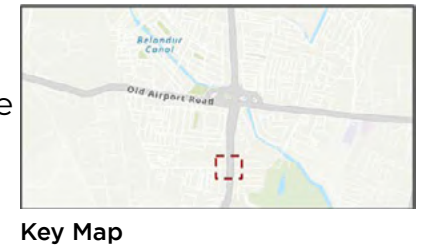
Pedestrian death and non fatal crashes have occurred in the same spot. Rumble strips & HRPCs have been proposed to reduce road crashes due to overspeeding by BTP. Since a new signal is installed, HRPC was recommended before it.

Image: HRPC executed

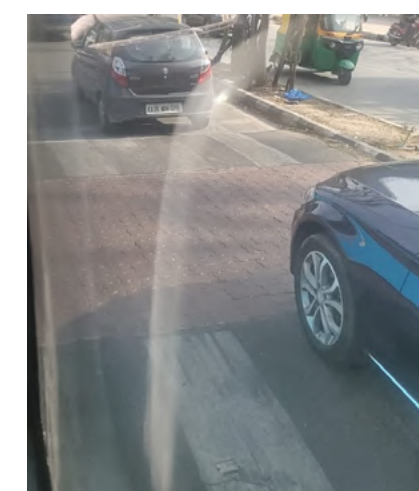
The 3 techparks in this stretch means frequent pedestrian crossing. BTP recommended to raise the median by 3 feet from the end of the flyover to the Airview junction. An HRPC along with the median refuge space in front of the DELL office would be the only break in this stretch so as to reduce pedestrian crashes. The position was decided to keep away from the down ramp of the terrain. We also propose the missing bus waiting shelter to be made closer to the HRPC.

Image: HRPC executed near DELL.

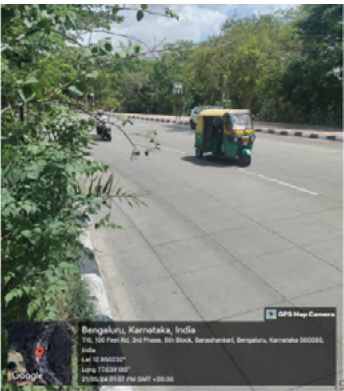
Image: Steep curve

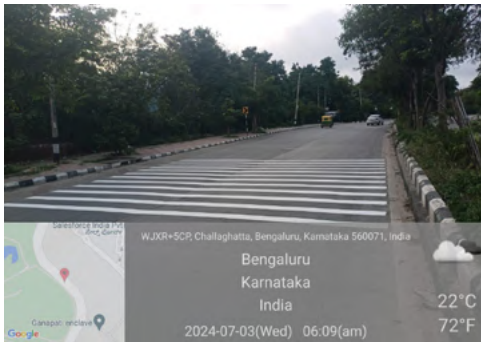
Image: Rumble Strips laid by BBMP TEC.

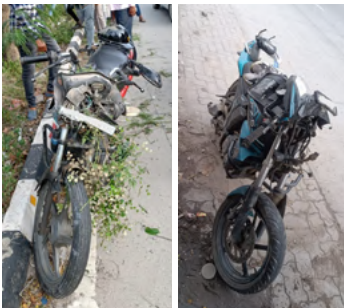
Image: Two wheeler crashes.

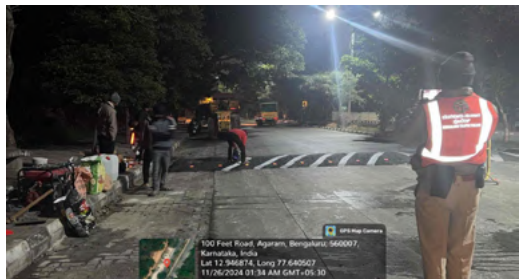
Image: Speed hump executed towards Indiranagar by BBMP TEC.

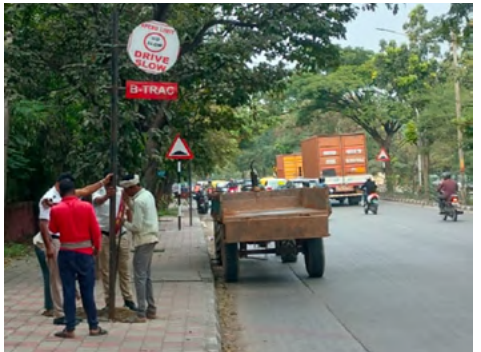
Image: Signage installed by BTP.

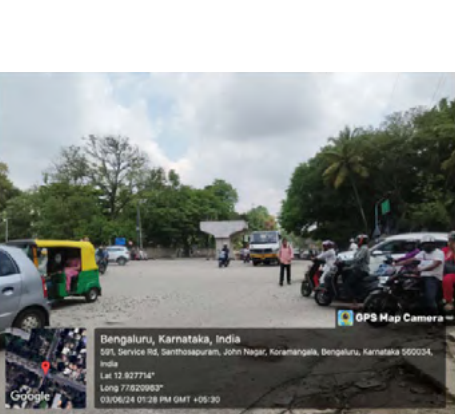
Zebra crossings and stop lines on all four sides have been proposed for the Kormanagala Water Tank junction, along with the installation of a speed hump to further reduce vehicle speeds in the area.

Image: Massive junction needs more definition.

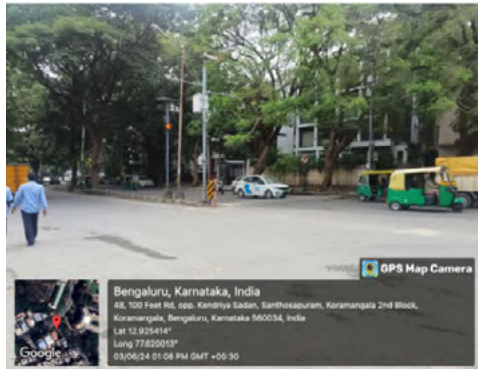
Images: No road markings present. Crossing the wide road is unsafe without dedicated zebra crossings.

- To be done on Site:**
1. Zebra crossings
  2. Stop lines
  3. Lane marking

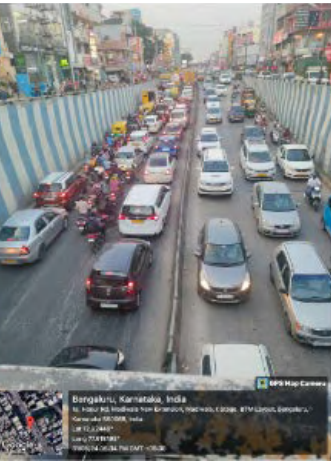
Image: The Madiwala underpasses observes Garbage dumping and flooding

- To be done on Site:**
1. Zebra crossings
  2. Stop lines
  3. Lane marking
  4. Median to be raised
  5. Barricades to be placed properly.
  6. 'No littering and fine' board to be installed.

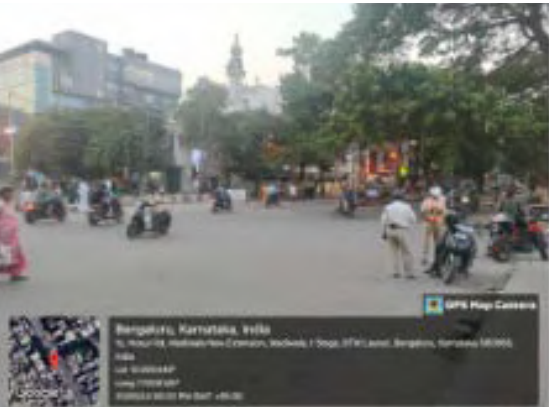
Image: Junction above the Madiwala underpass.

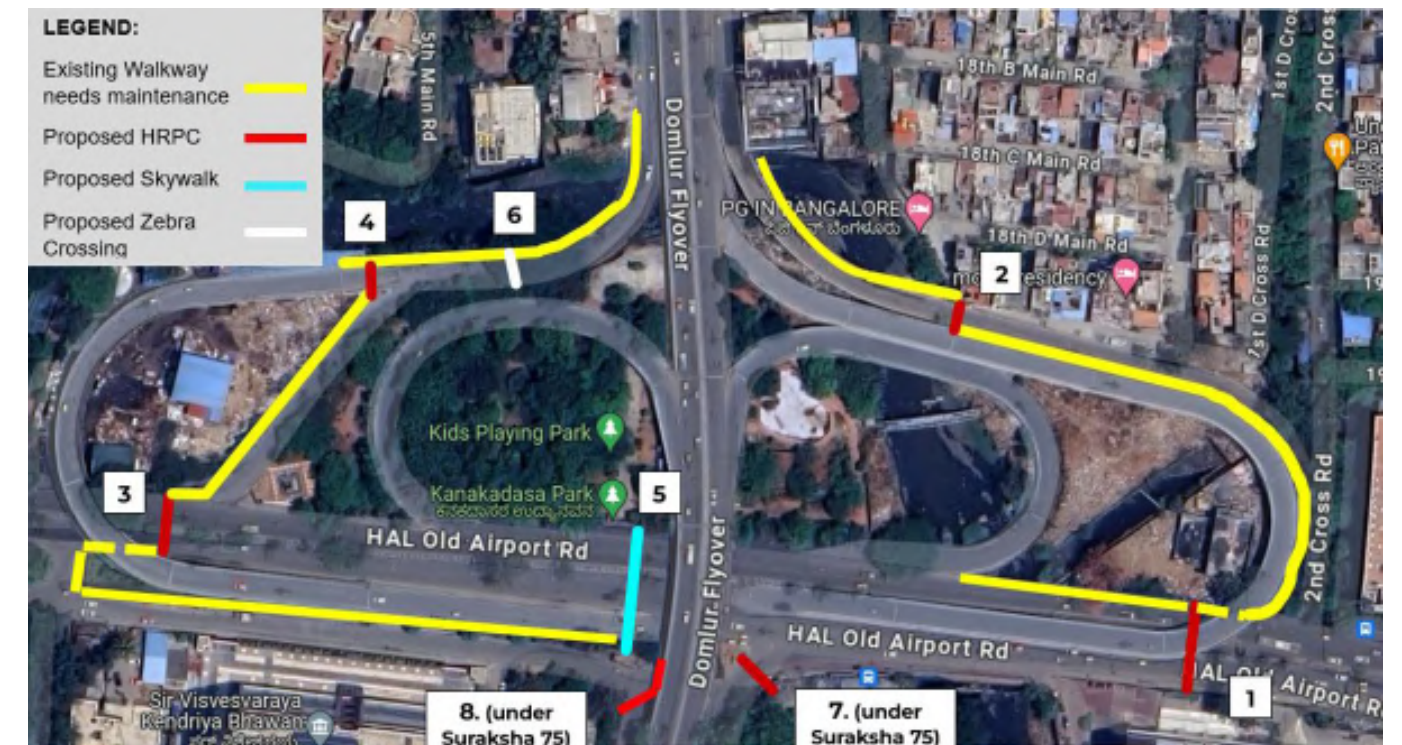
The Domlur Flyover, meant to ease traffic, has hindered pedestrian mobility. The disconnected walkways make it difficult for pedestrians to navigate safely, forcing them to cross busy roads with fast-moving vehicles, risking their safety. The lack of pedestrian crossings and foot-over-bridges worsens the issue, forcing people to take longer routes. The flyover's design creates barriers across its four sections, blocking pedestrian access entirely.

Image: Proposed interventions on 2D map.

To improve safety and accessibility, we propose six interventions to enhance pedestrian infrastructure and ensure safer movement in this congested part of the city. This was coordinated with **MayaPraxis**, the design consultant for the HAL old Airport road- HDC improvement, Bengaluru Traffic Police & BBMP TEC.

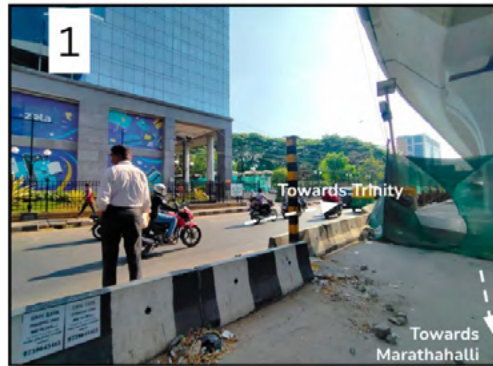
The downward ramp leading from Domlur flyover to Old Airport Road makes it difficult for vehicles to reduce their speed, posing a risk to pedestrians trying to cross at road level.

Image: About 20 pedestrians cross here, every 10-15 minutes from both sides.

**Proposal:** Provide High Rise Pedestrian Crossing Facility with Rumble strips and metal bollards on the existing median. This crossing connects to an existing footpath which needs major repair.

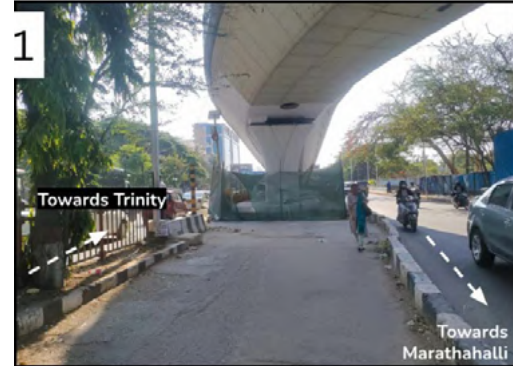
Image: Vacant space below the flyover can be developed.

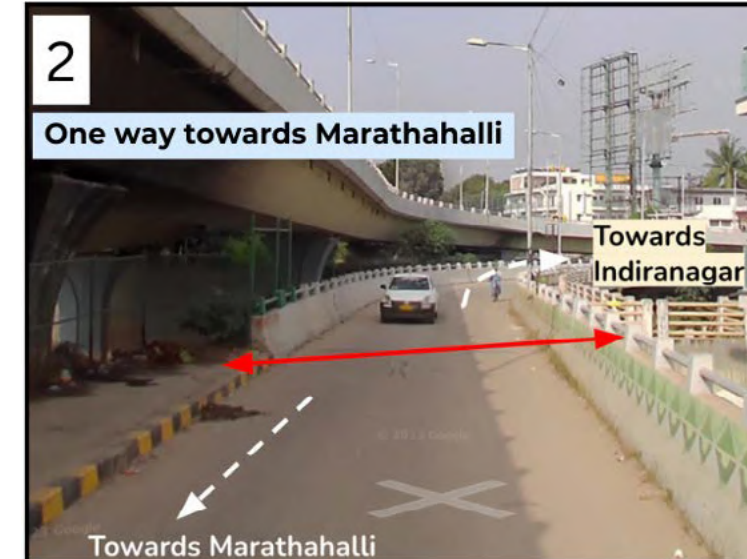
The walkway along the flyover is discontinuous and abruptly stops on each side. An HRPC crossing is required to connect the two.

**Proposal:** Connecting disconnected walkways along the flyover. HRPC with rumble strips before it. Existing footpath barricade on staircase side needs to be opened.

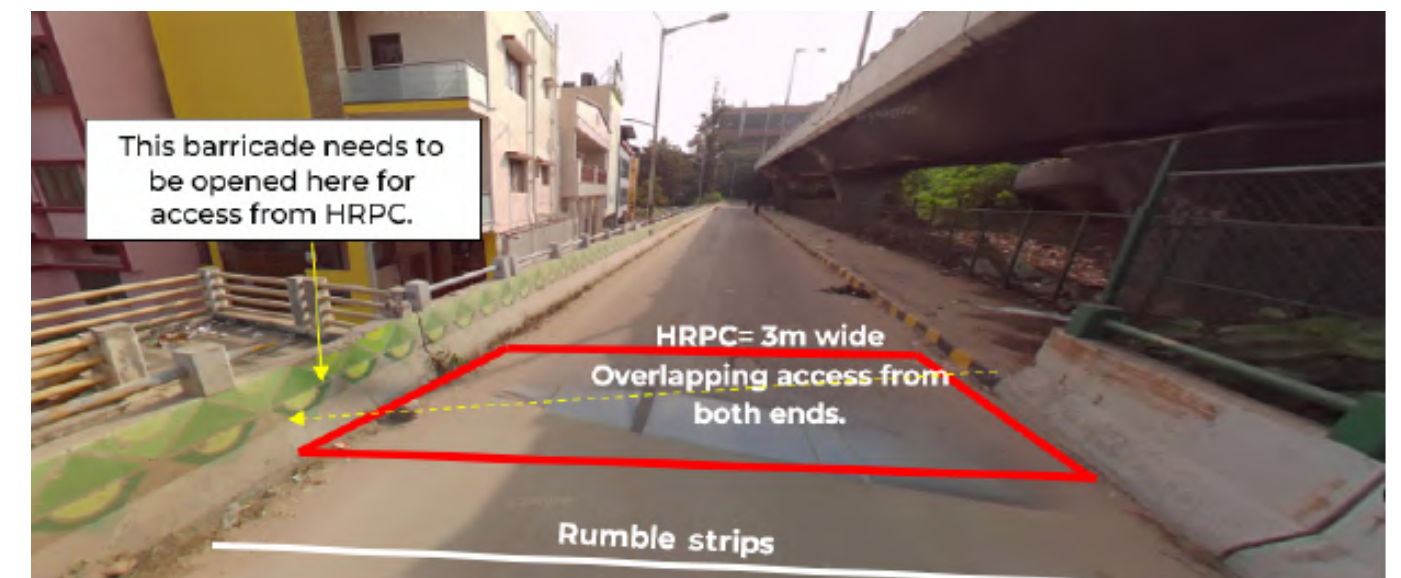
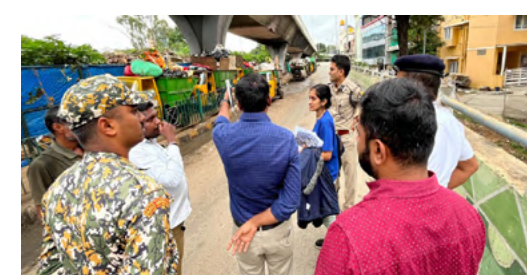
**Site visit:** Garbage trucks being parked at the walkway. BTP instructed for it to be removed.

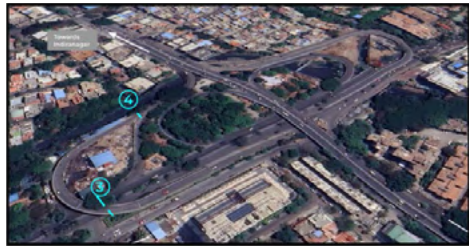
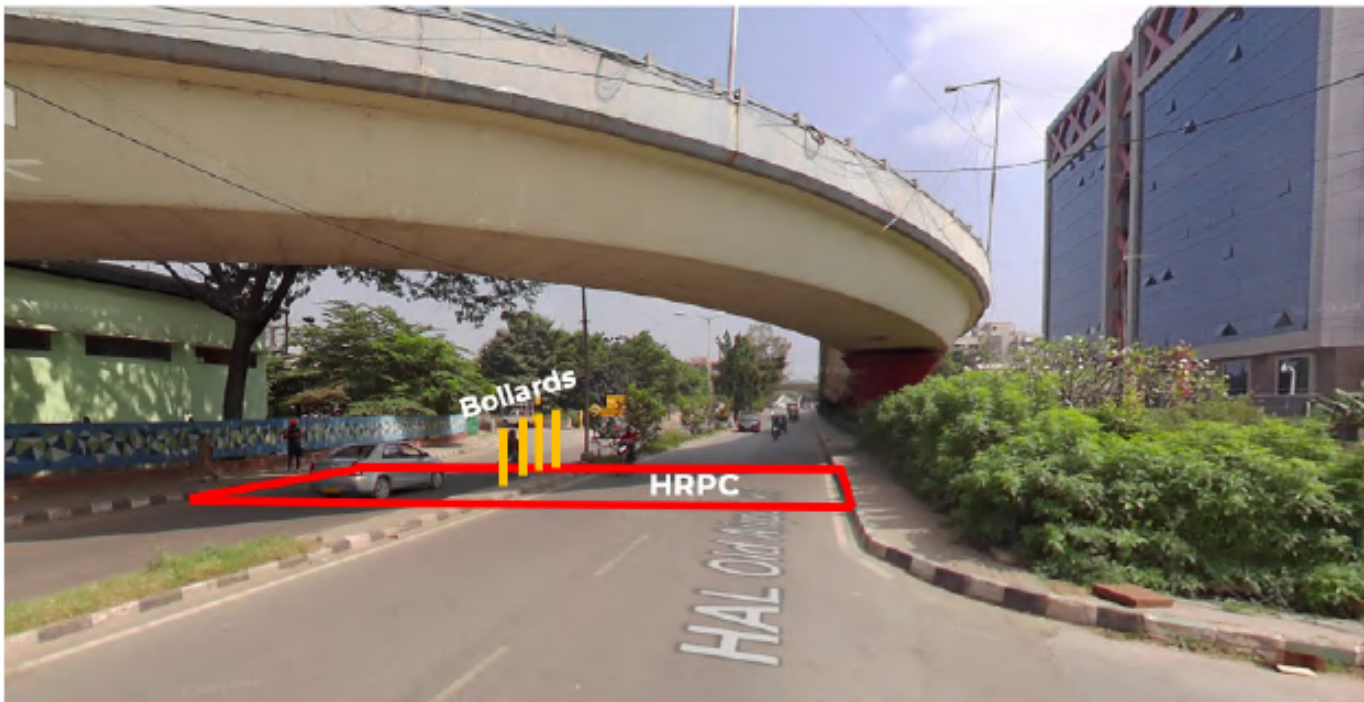
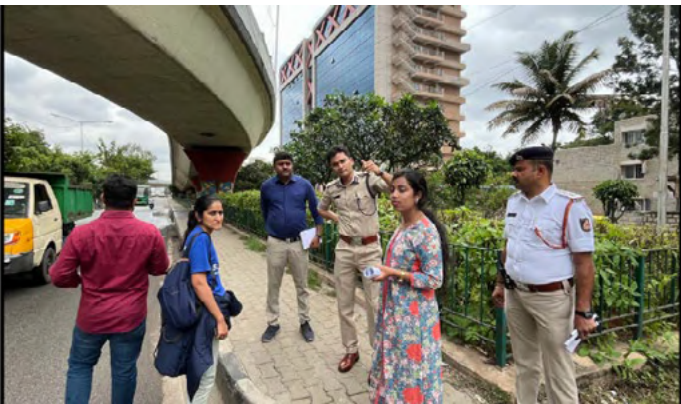
Intervention 3

There is no way for pedestrians to cross the Old airport road. Hence a safe crossing at the nearest opening is recommended, as it will connect to a walkway along the flyover.

Proposal: High-Rise Pedestrian Crossing (HRPC) with rumble strips and bollards at the median on the HAL Old Airport Road. This crossing will connect to the existing footpath leading to Intervention 4. Vehicles may not stop if there is only zebra crossing. Adequate and complimentary signboards are required at crossings and 200m away from crossings as well.

Site visit: Discussions on site.

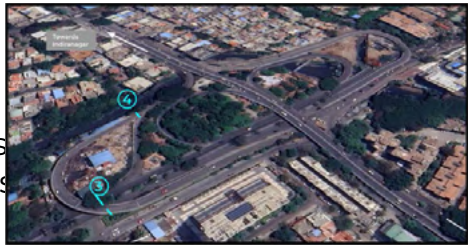
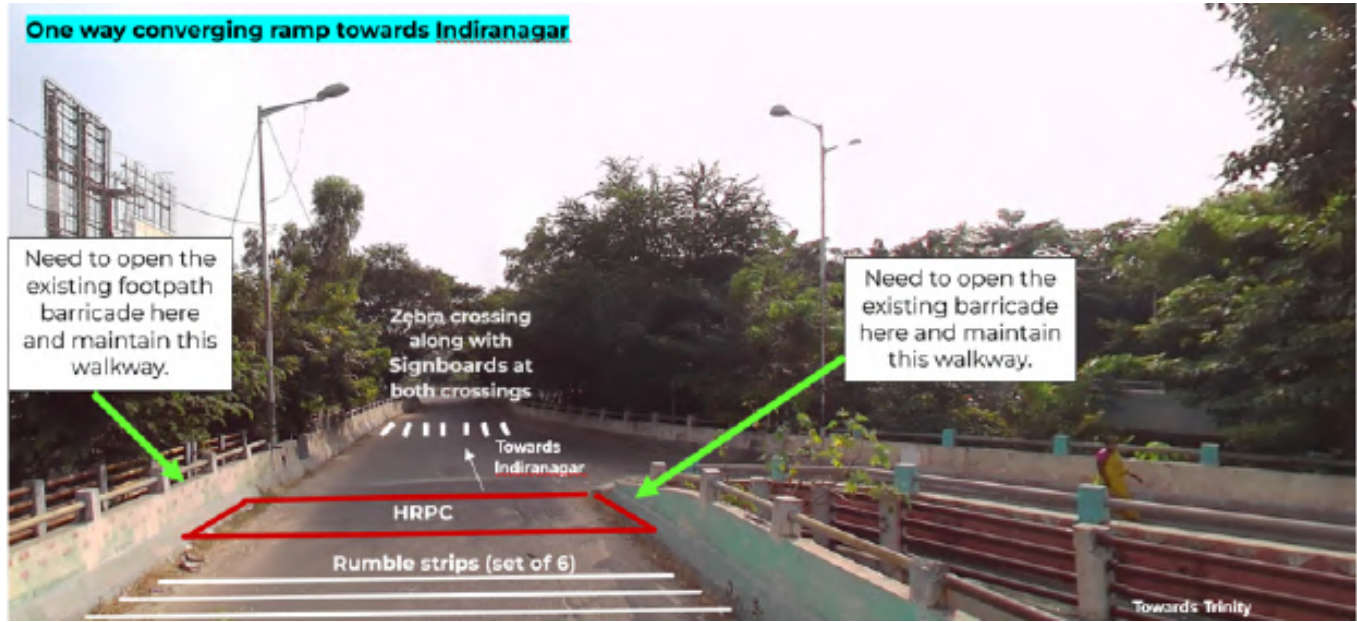
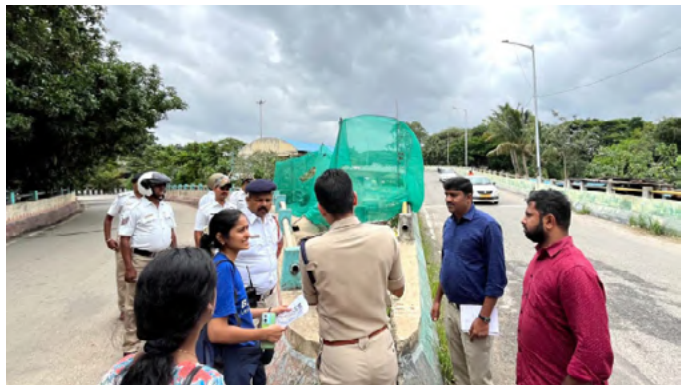
Intervention 4

Walkways along the flyover are currently not maintained, rendering them inaccessible. Giving access and crossings at the right locations will help pedestrians walk to Indiranagar and to Kormangala.

Proposal: HRPC along with rumble strips on the downward ramp. Open the existing footpath Barricade on the both sides of the HRPC to make use of existing walkways. Maintenance of walkways and installation of signboards.

Site visit: Assessing traffic calming and pedestrian safety at the down ramp. At present, pedestrians walk along with vehicles on the flyover.

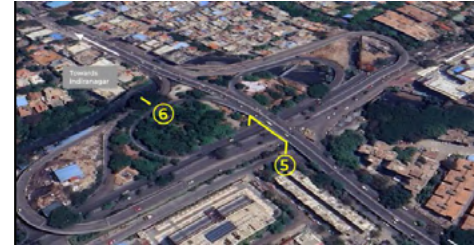
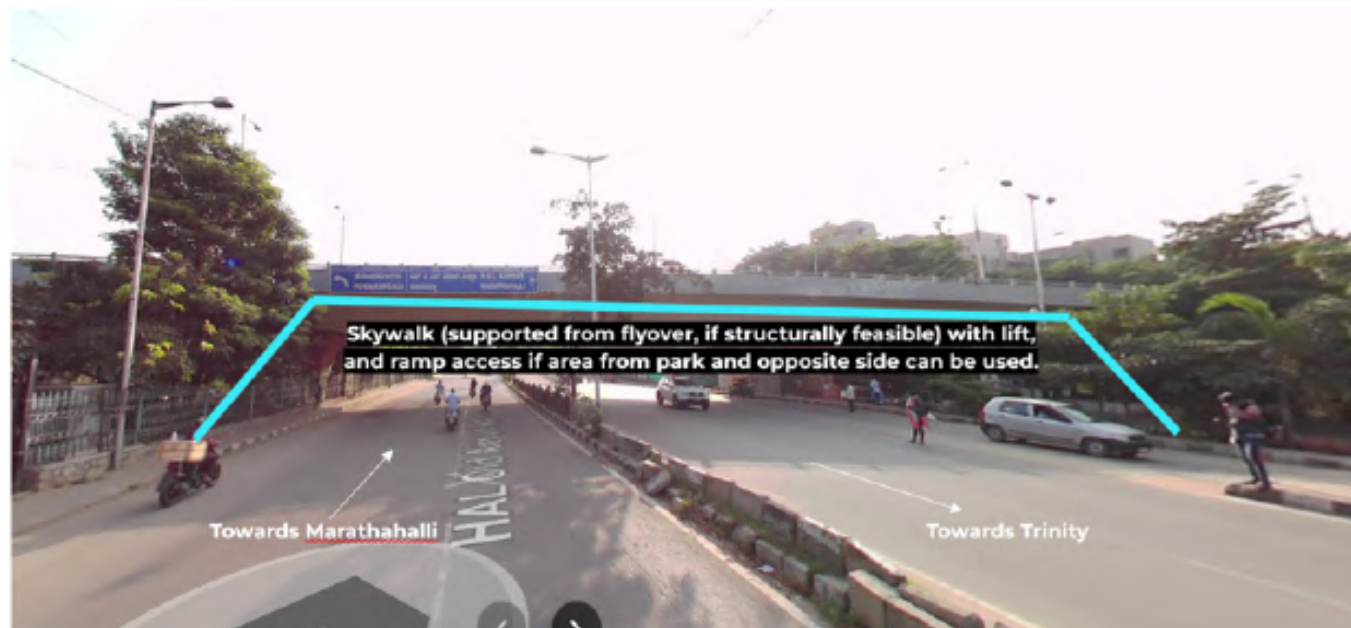
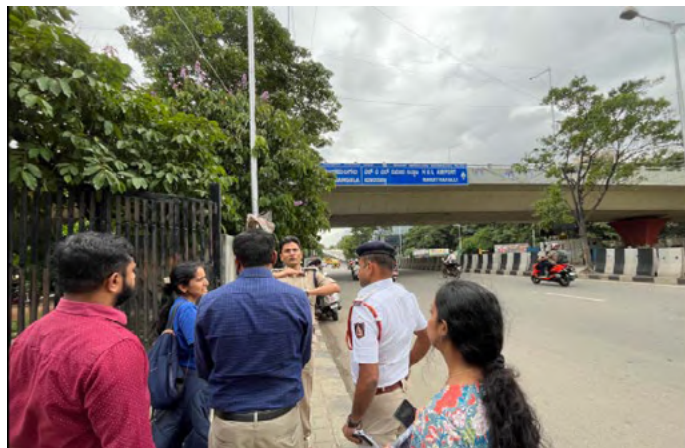
### Intervention 5

Pedestrian accessibility has been completely cut off with high median barricades. The junction witnesses vehicles speeding from the downward ramp towards Old Airport Road which poses as a road safety threat if pedestrian crossing is provided here. The position is equidistant for people who want to reach the other side towards Marathahalli or Trinity.

Proposal: Sky Walk with Lift and ramp if space permits; this facilitates the pedestrians to cross across the four lane HAL Old Airport and leads to Kanakadasa Park. It will be equidistant to both sides, left and right. The location for skywalk needs to come to a consensus.

Site visit: Access through skywalk was discussed.

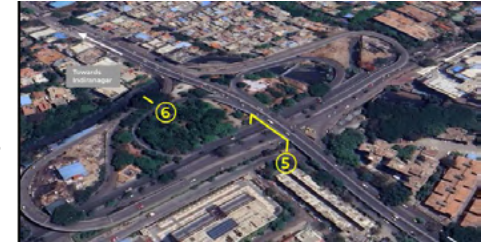
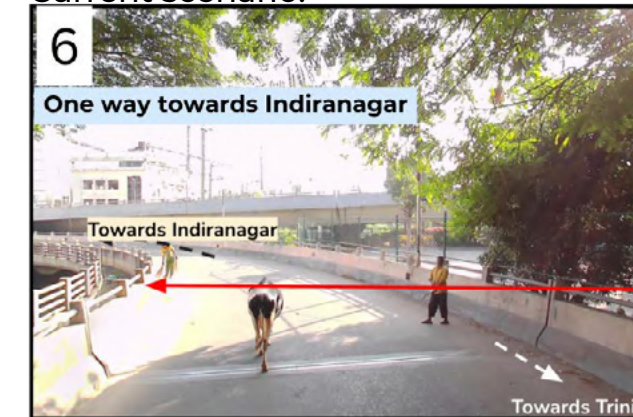
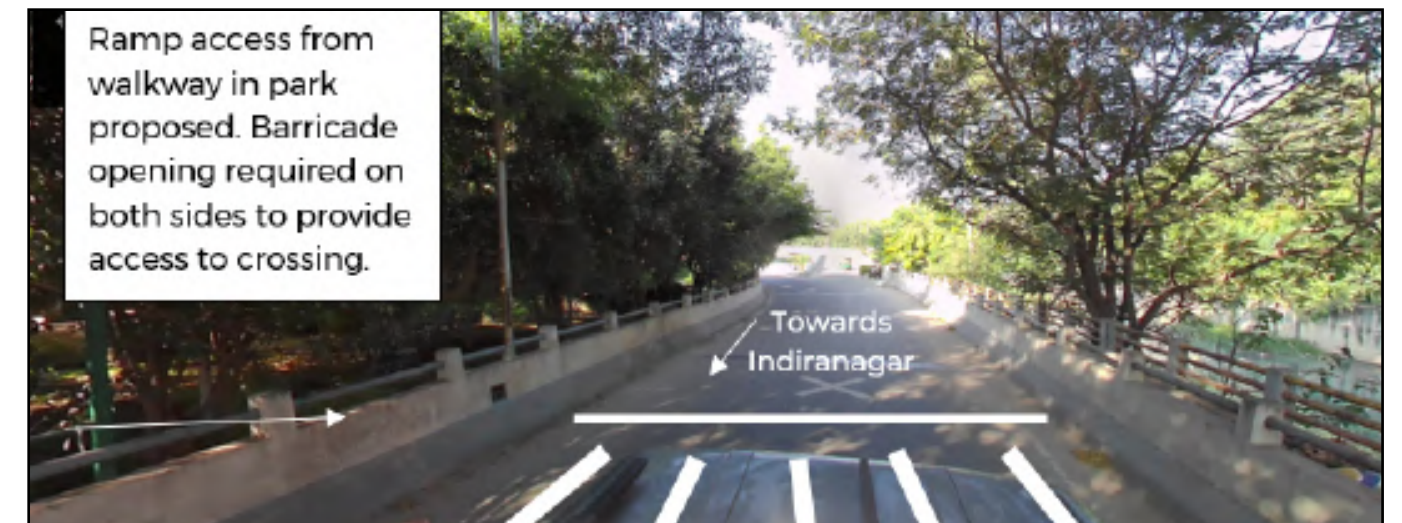
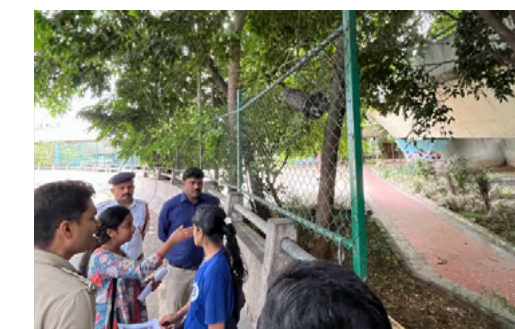
### Intervention 6

Maintenance of walkways along flyover is a must to make the existing infrastructure usable. Tactical routes need to be opened up in order to make the Domlur flyover accessible by foot.

Current scenario:

Proposal: Skywalk will provide access to Kanakadasa park and from inside direct access at grade level is possible to Indiranagar. Zebra crossing with stop line. Barricade opening is needed (with gate opening inside on park end) for access to the crossing on both sides. Blinker and signboards need to be installed. Adequate streetlight is needed. Walkways have to be maintained and rusted metal barricade near nala needs to be cleaned.

Site visit: This will reduce the pedestrian route length significantly. For pedestrian safety measures and trials before execution will be good.

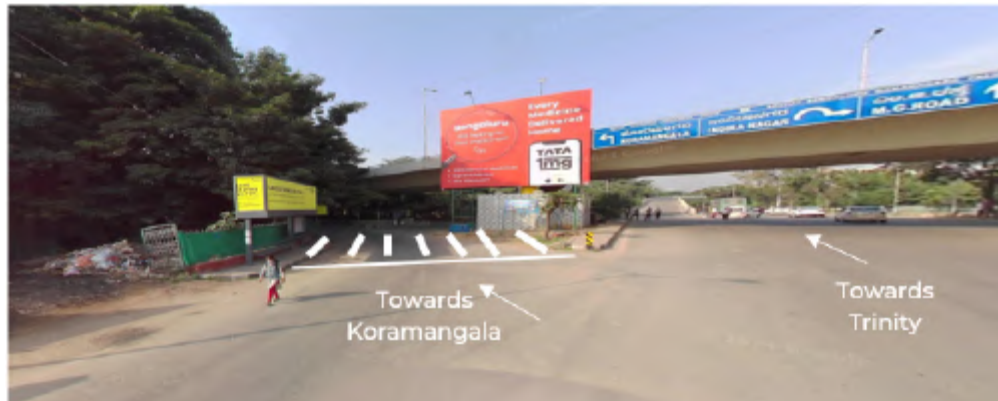
### Intervention 7

Proposal: HRPC proposed location as per Suraksha 75 proposal. Frequented by bus users.

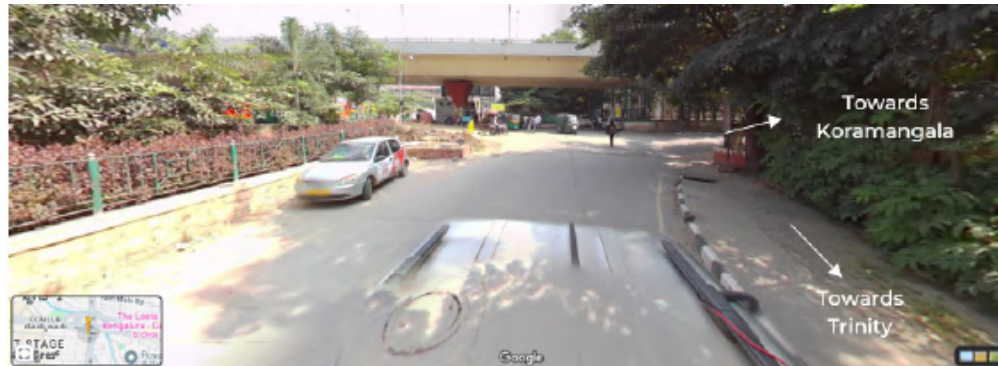
### Intervention 8

Proposal: HRPC proposed location as per Suraksha 75 proposal.

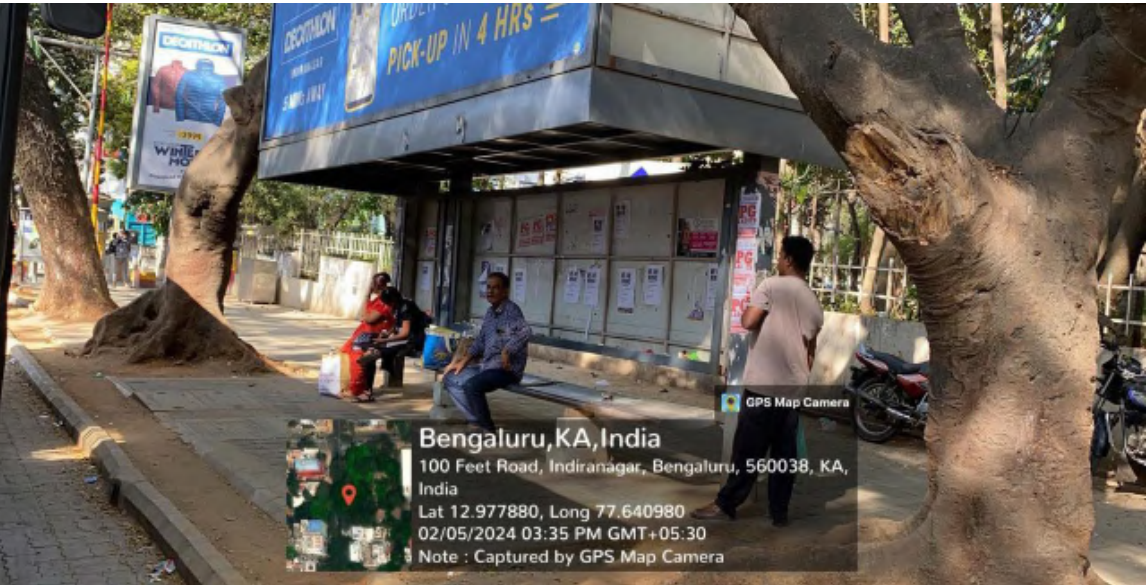
- This bus waiting shelter needs maintenance.
- Apart from the seating and shelter, the rest of the amenities are lacking.
- However it is neat and clean.

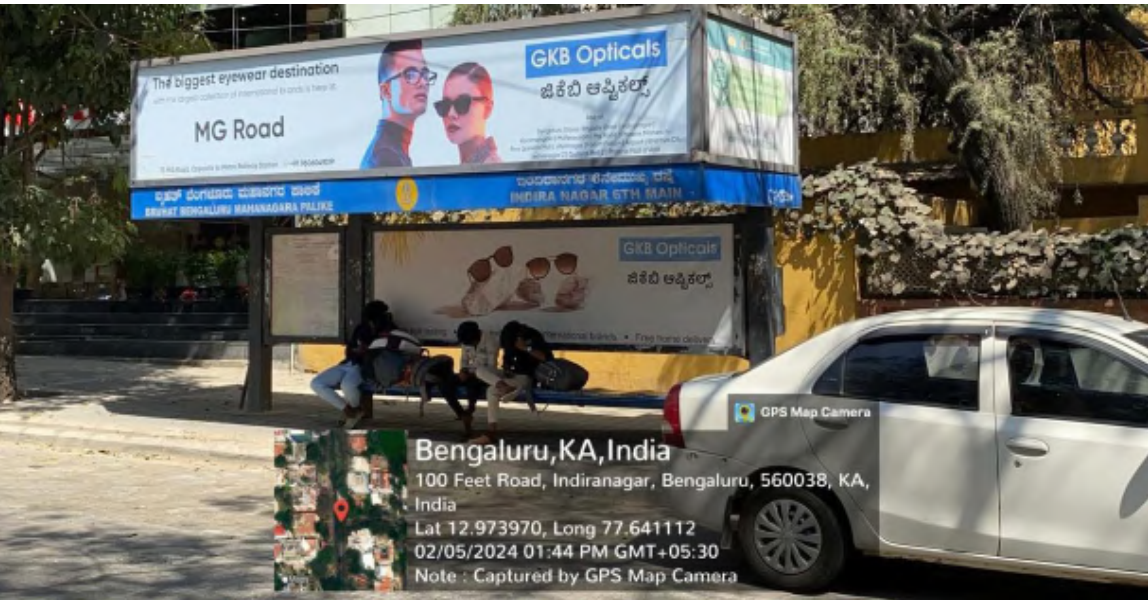
13.1.2 Bus Stop: Indiranagar 6th Main (towards Koramangala)

- This is a well maintained bus stop.
- It is very neat and clean.

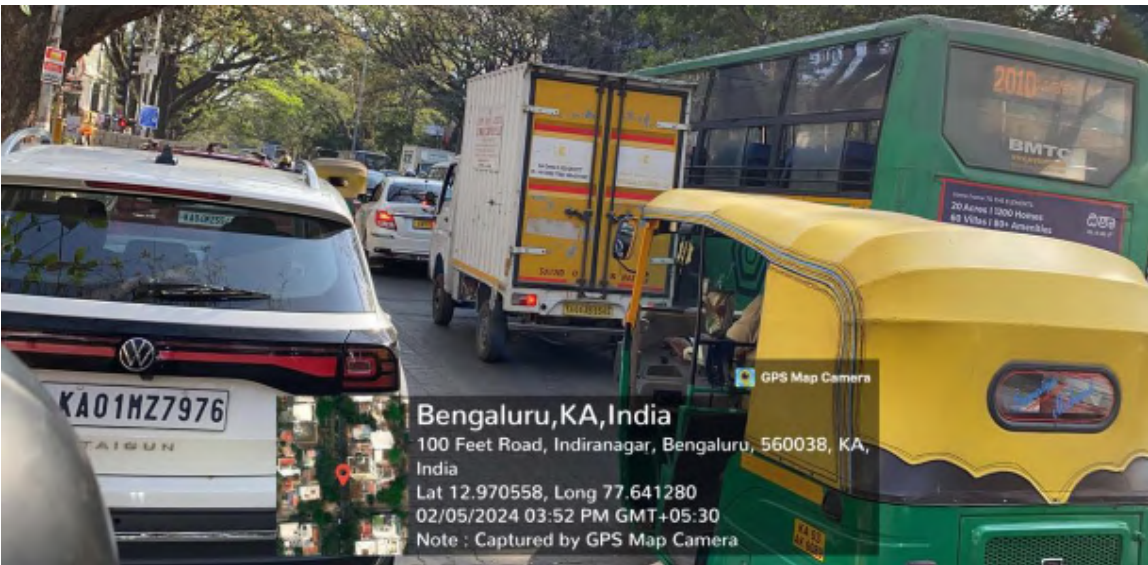
13.1.4 Bus Stop: New Horizon (towards Koramangala)

MISSING

- Missing bus shelter
- People wait on the footpath for the bus.
- The bus halts close to the footpath to pick passengers.
- Proposed location: <https://maps.app.goo.gl/j7Kit3daxnJN4p3F7>

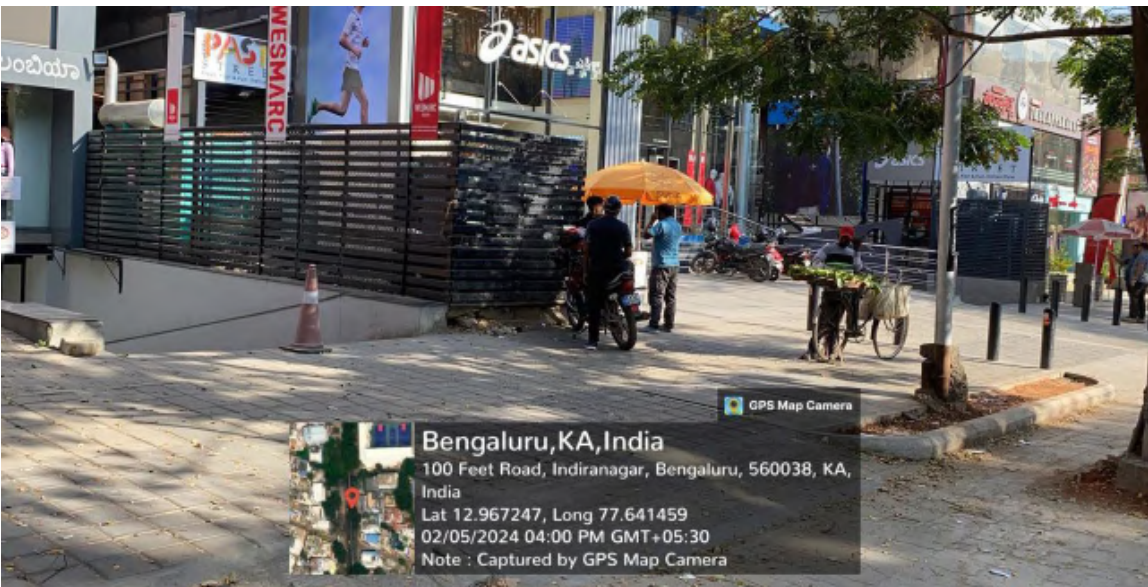
### 13.1.5 Bus Stop: Dhoopanahalli (towards Koramangala) **MISSING**

- Missing bus shelter.
- The bus halts close to the footpath to pick passengers.
- Proposed location: <https://maps.app.goo.gl/BFRJV6T7EEq85WKB8>

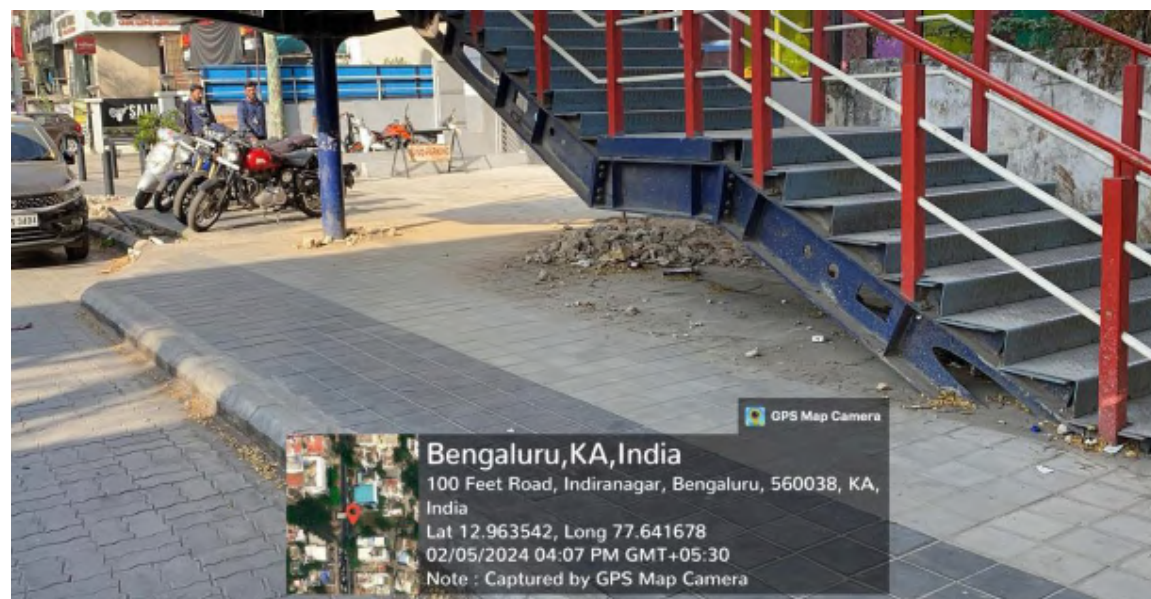
### 13.1.6 Bus Stop: Domlur flyover (towards Koramangala) **MISSING**

- Missing bus shelter.
- The bus halts close to the footpath to pick passengers.
- Proposed location: <https://maps.app.goo.gl/zn2XdDepDnPDAHEn8>

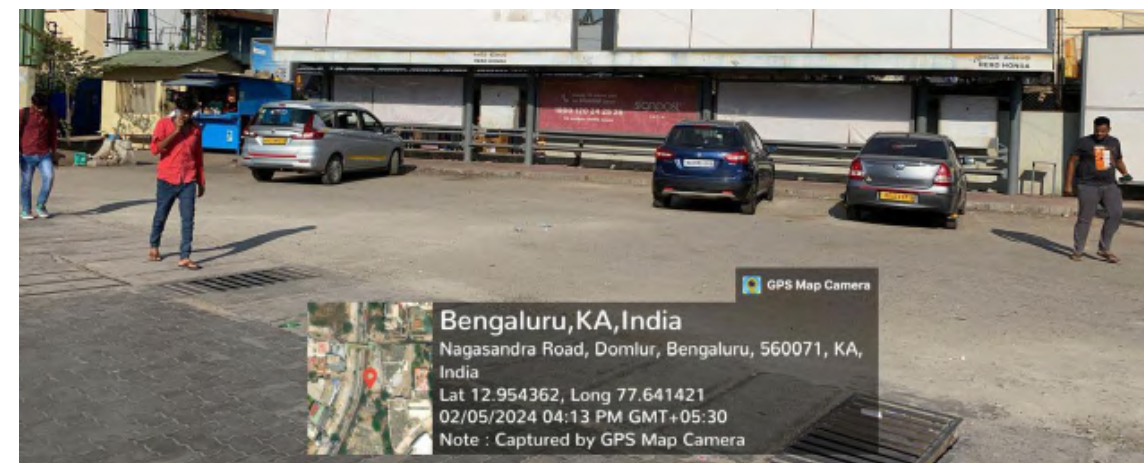
### 13.1.7 Bus Stop: Hero Honda (towards Koramangala)

- Long seating and shelter.
- Maintenance and updatation required.
- Bus bay is occupied by taxis, buses don't halt inside.
- Bus bay needs to be closer to road and redesign proposal shared in Road markings PDF.

The massive bus bay with 5 waiting shelters remain unused because bus drivers halt below the skywalk, and taxis park at the bay while having food, making passengers stand and wait below the skywalk.

The area behind the redesigned bay (closer to the road) can be landscaped with trees, seating and walkway.
