# Street: Standstill to Active

A Comprehensive & Collaborative Approach to Sustainable Mobility

Improving Bus reliability, Walkability & Road Safety  
7.5km of Inner Ring Road (IRR)

July 2025

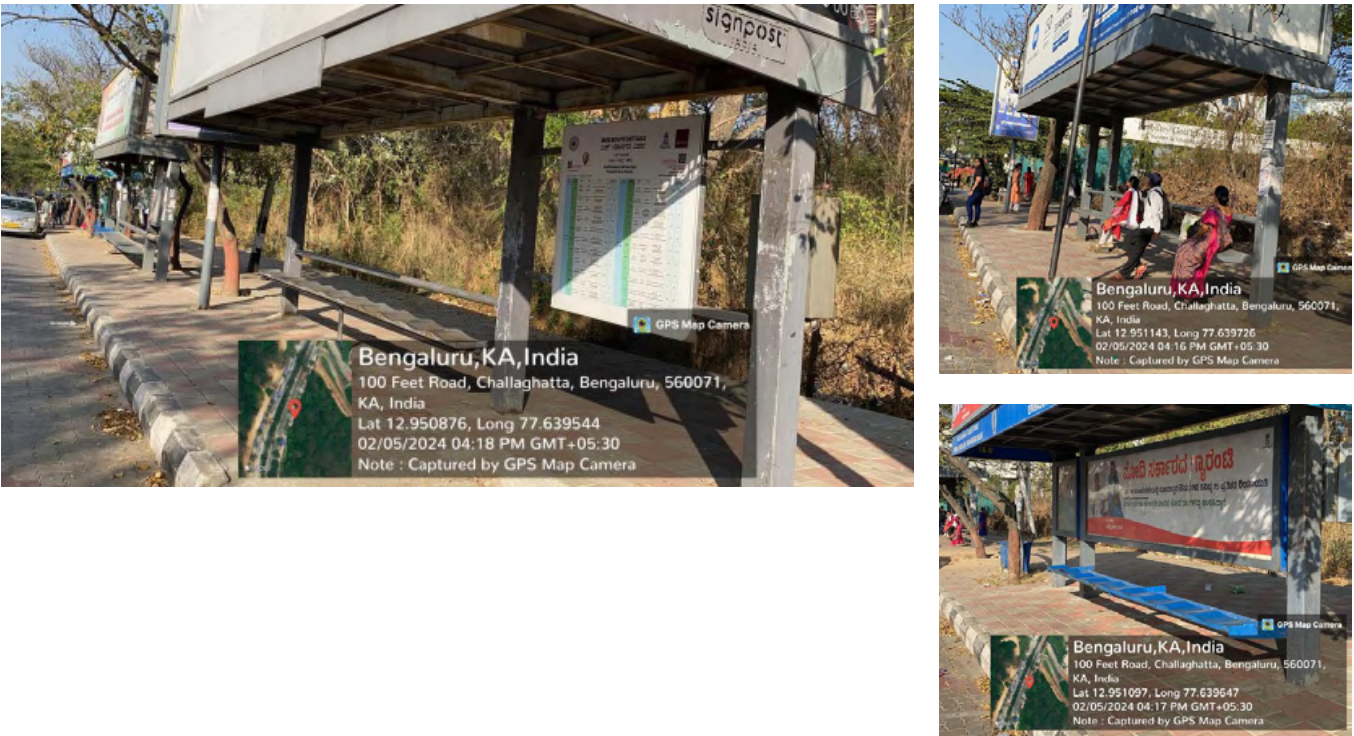
13.1.9 Bus Stop: Ejipura (towards Koramangala)

- This bus stop needs maintenance.
- The footpath is broken.
- The space behind the bus stop has garbage dumped.
- E-display of ETA available

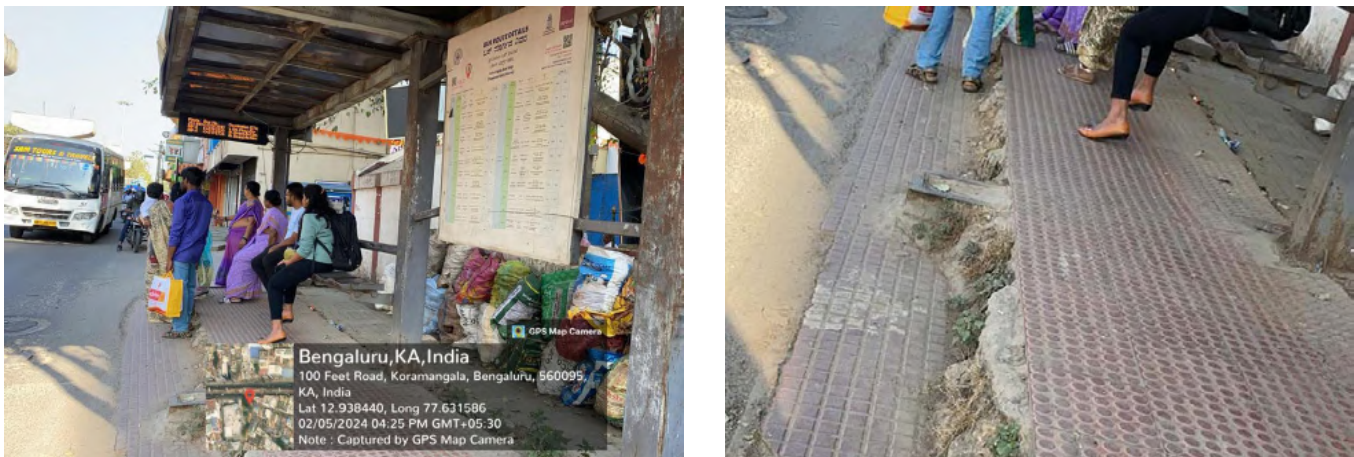
Image: Ejipura Bus waiting shelter towards Koramangala

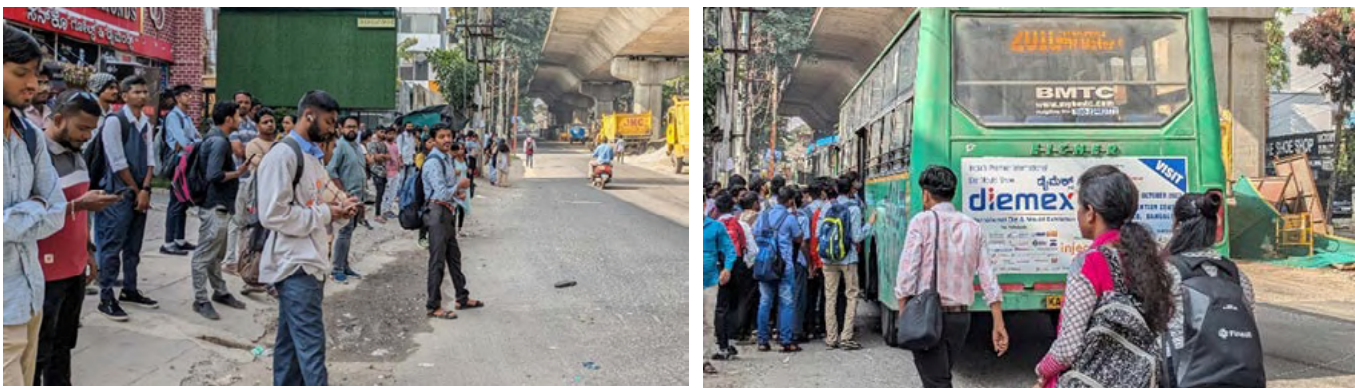
13.1.10 Bus Stop: Sony World (towards Koramangala) MISSING

- Missing bus waiting shelter. Hence, people stand for long during delays.
- The bus halts close to the junction to pick passengers.
- During bus bunching, junction gets blocked.
- Proposed location: <https://maps.app.goo.gl/9nVVp7TsTxD4RUaa9>

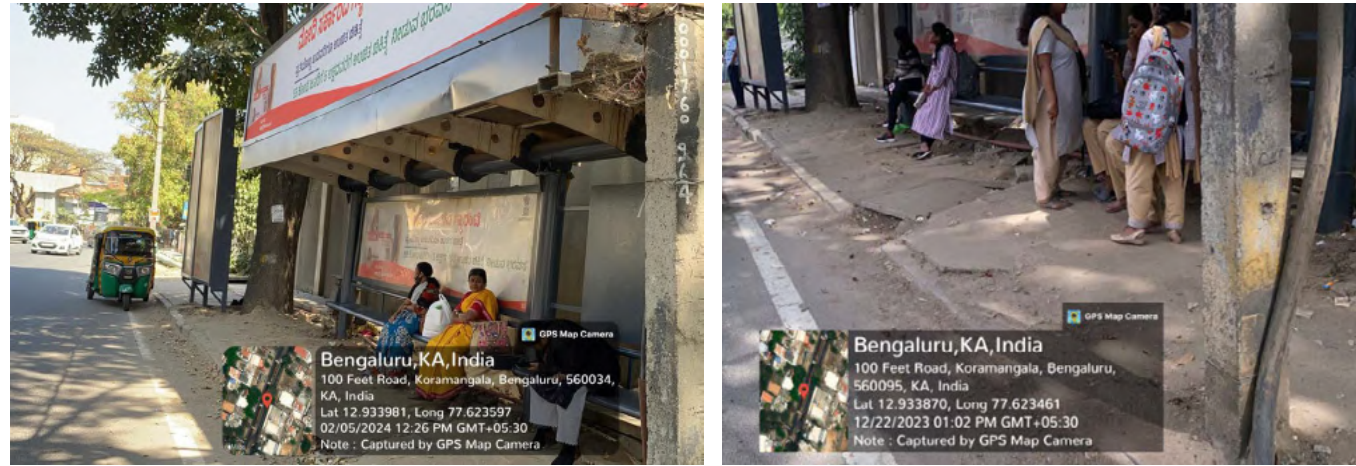
### 13.1.13 Bus Stop: Koramangala Water Tank (towards Koramangala)

- Footpath- Missing/ broken
- Open drain filled with garbage behind the bus shelter.
- Debris and waste around the bus stop.
- Dusty surrounding

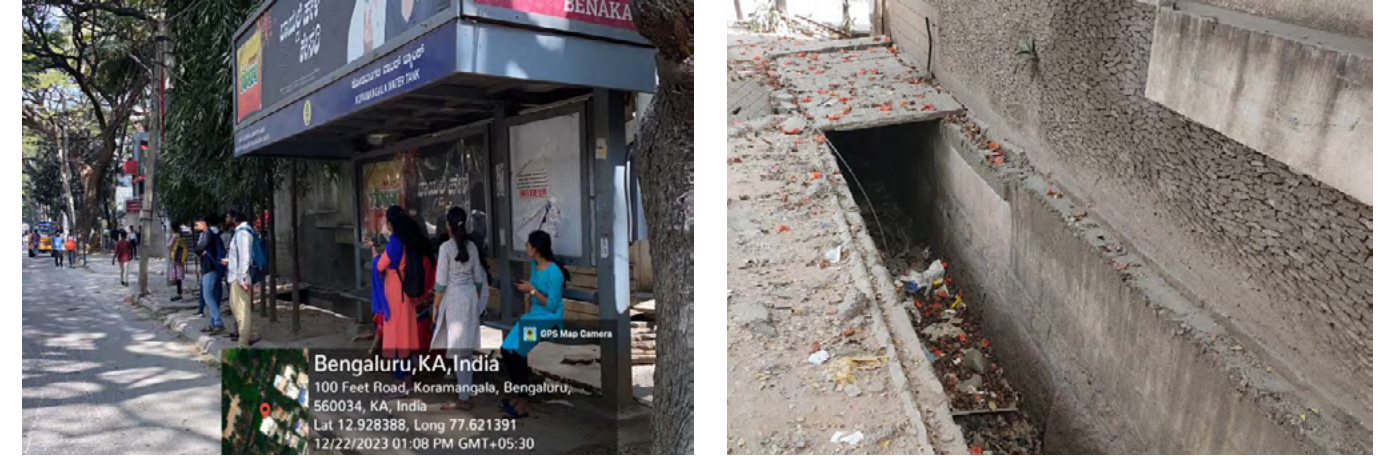
### 13.1.12 Bus Stop: Koramangala BDA Complex (towards Koramangala)

- This bus stop has two shelters.
- E-display of ETA present.
- Pavers missing in front of one shelter.
- Apart from that it is maintained well.

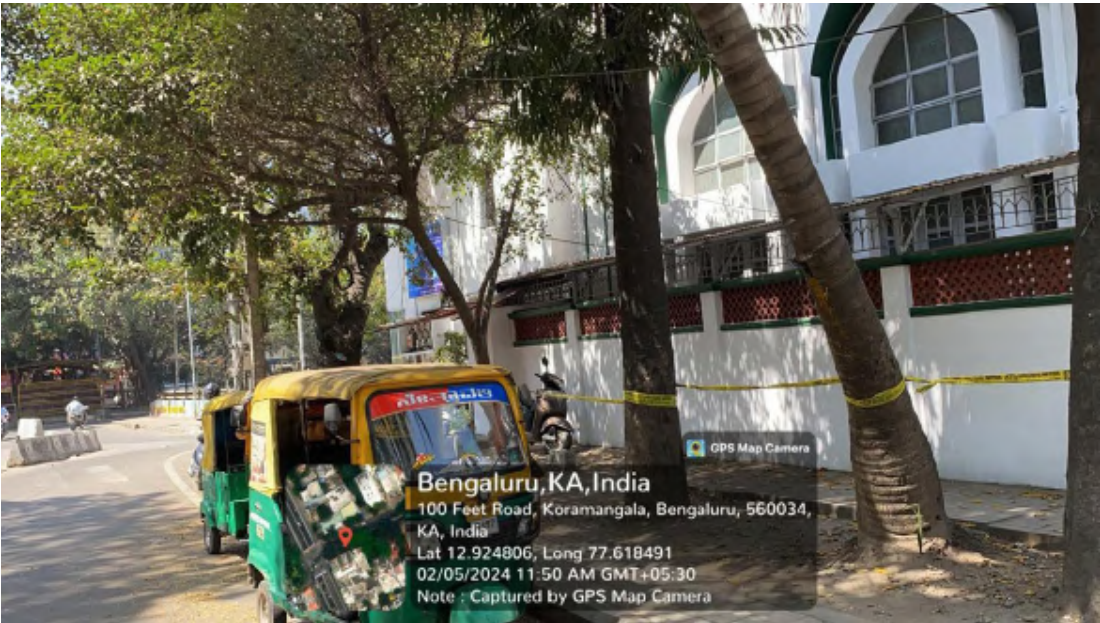
13.2.1 Bus Stop: Madiwala Masjid (towards Indiranagar) MISSING

- Missing bus shelter.
- Proposed location: <https://maps.app.goo.gl/URfrrvG1Z526nUJK8>

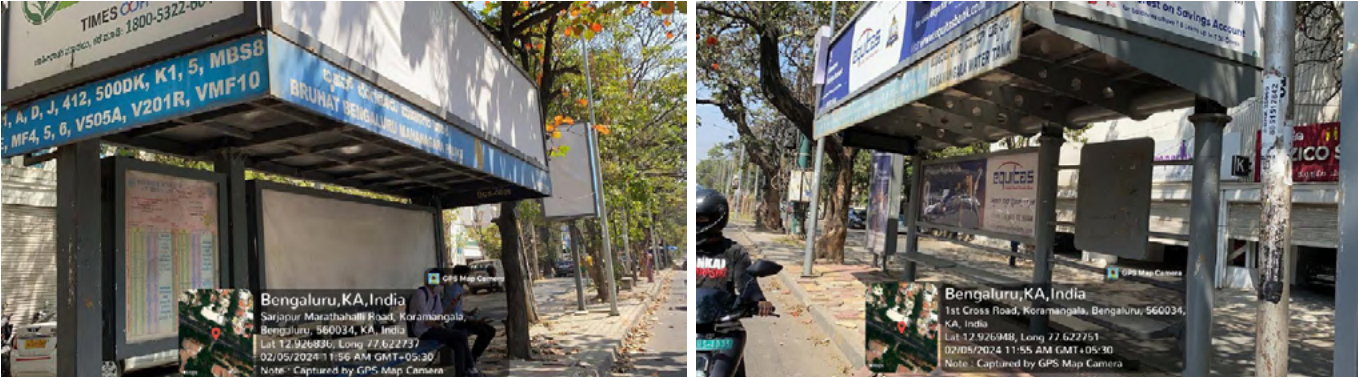
- There are two bus shelters.
- Both are in a good condition.
- One has the bus routes (to check for updates).
- Footpath -broken pavers.
- E-display present but no LIVE ETA from BMTC.

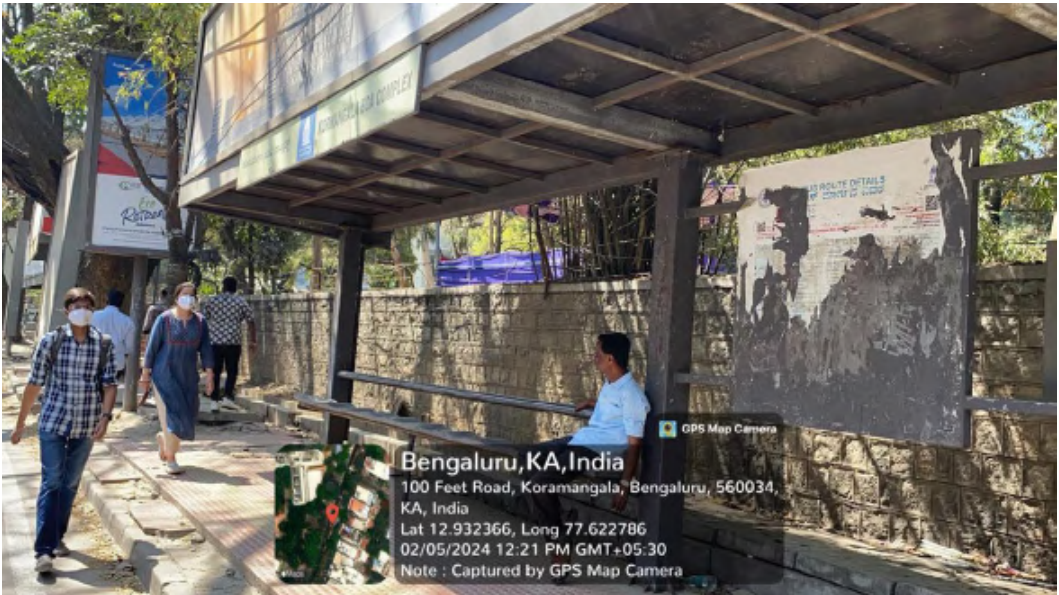
### 13.2.3 Bus Stop: Koramangala BDA Complex (towards Indiranagar)

- This bus shelter needs maintenance.
- The bus routes has been torn up.
- Footpath- pavers broken towards kerb
- Access to bus stop- not good, in different levels.

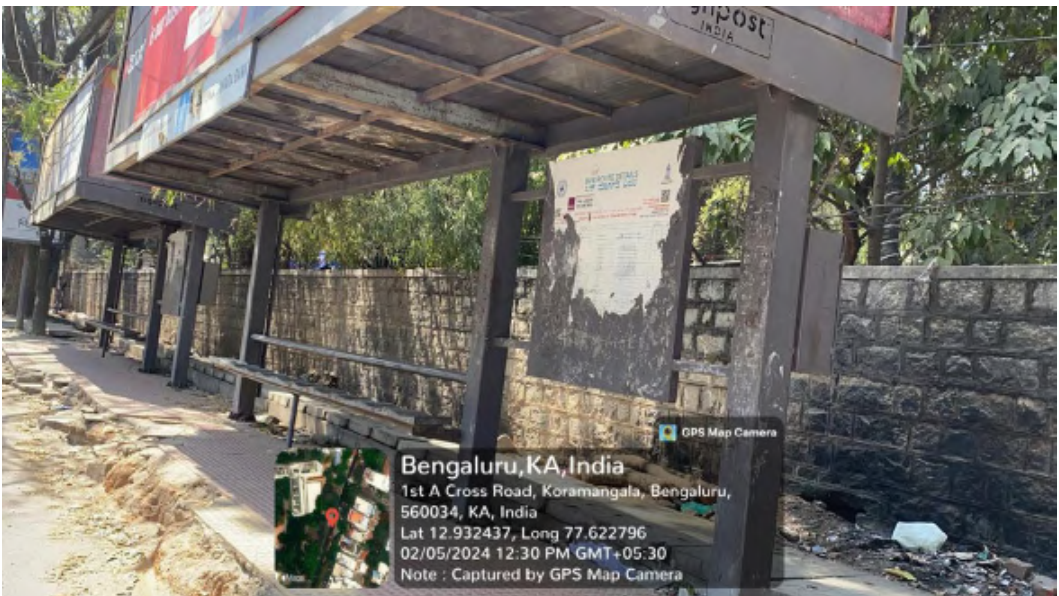
### 13.2.4 Bus Stop: Canara Bank (towards Indiranagar)

- This bus stop needs maintenance.
- It only has a shelter and seating.
- The other amenities need to be maintained properly.
- There is waste thrown behind the stop.

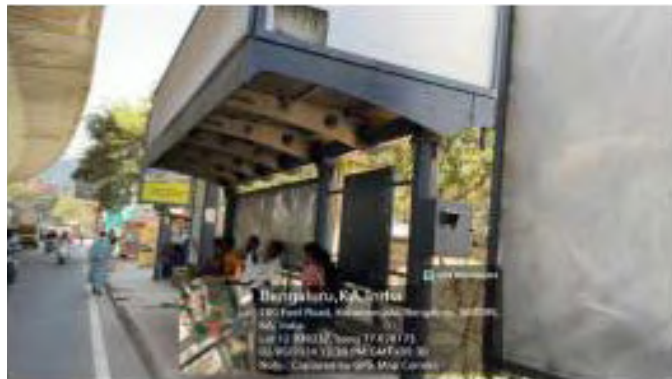
Image: Shelter 1

- There are four bus shelters.
- Footpath in 2 levels. To be made uniform at elevation of 150mm from road level.
- Out of the four, only one has the name of the stop.
- Two of the shelters have the bus route information.
- One of them has the e-display of ETA.
- Garbage and tender coconut sheels dumped beside and behind the shelters.
- Repositioning to make it accessible
- Proposed location: <https://maps.app.goo.gl/G9emCsIT6ZrPxtF67>

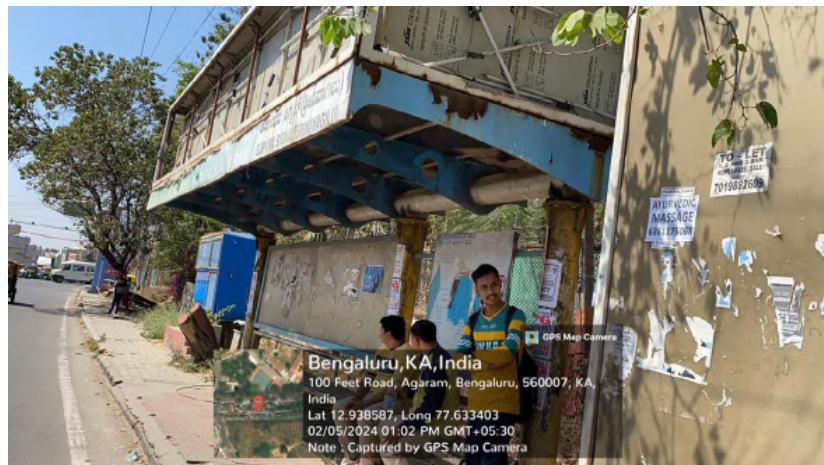
Image: Condition in May 2024

- It is in a very poor condition.
- There was garbage littered around the bus stop and smelling bad.
- Unfortunately even in June 2025, the condition has gotten worse, with the footpath been dug up for a year for Stormwater and other utility pipes fixing. Sewage from the defence land flows openly into this dug up portion.
- Dark at night.

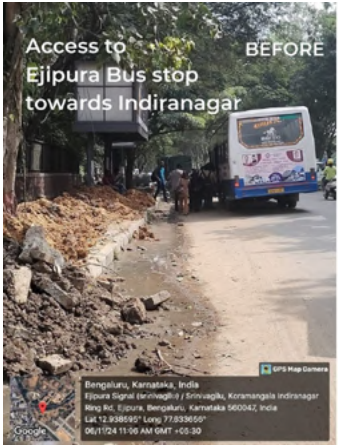
Before- No access to bus stop. Soil dug up- December 2024

After- Temporary walkway created by contractor in December 2024 after follow ups from BBMP and B.PAC's advocacy.

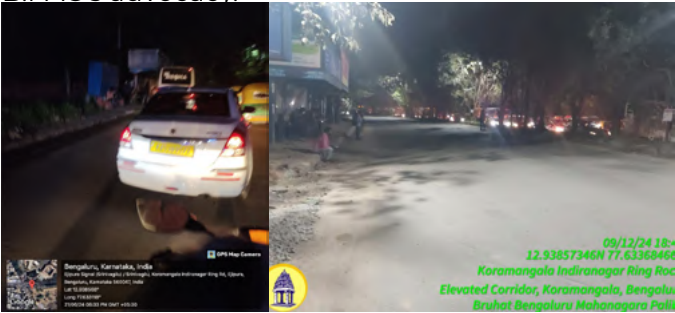
Image: The access to Ejipura Bus stop and shelter got temporary lights due to our advocacy. (Explained in streetlight audit section.)

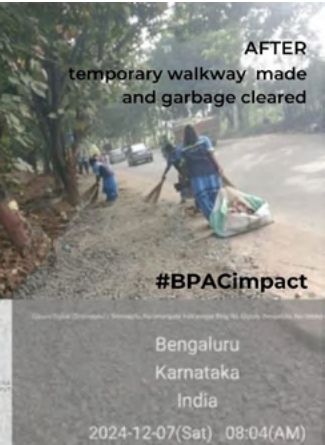
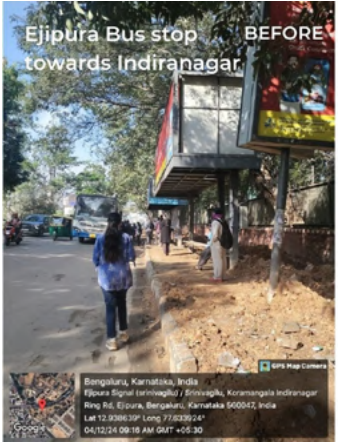
Before- Bus waiting shelter condition is very poor. After- Cleanup conducted by Pourakarmikas.

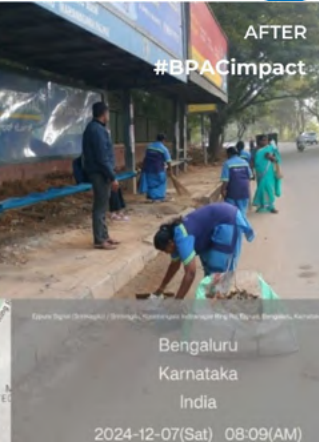
Image: Unfortunately it has gone worse in April 2025. No improvement, while commuters bear

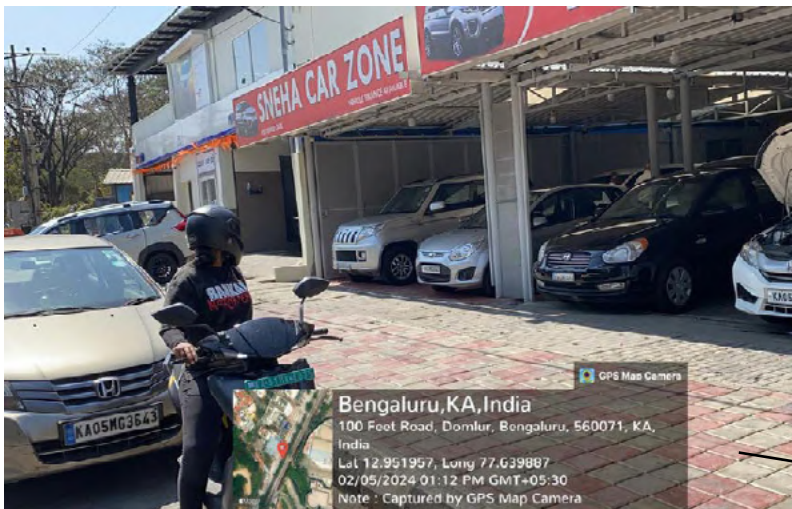
- Missing shelter at bus stop adjacent to major tech parks.
- Proposed location, near Hyundai: <https://maps.app.goo.gl/g6cJPogMri9rGP8FA>

Image: Buses usually stop in front of this, opposite to EGL. Downramp of terrain makes it hard for vehicles to reduce speed here.

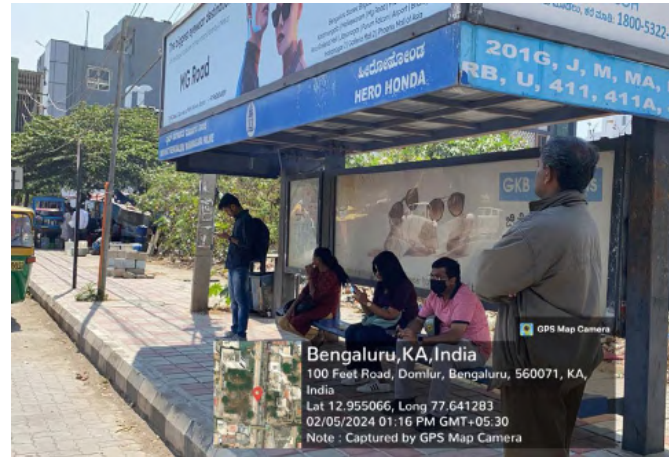
- The bus stop is well maintained.
- However, the space behind the bus stop is littered with garbage.
- E-display is present

Image: Well maintained bus stop with ETA display

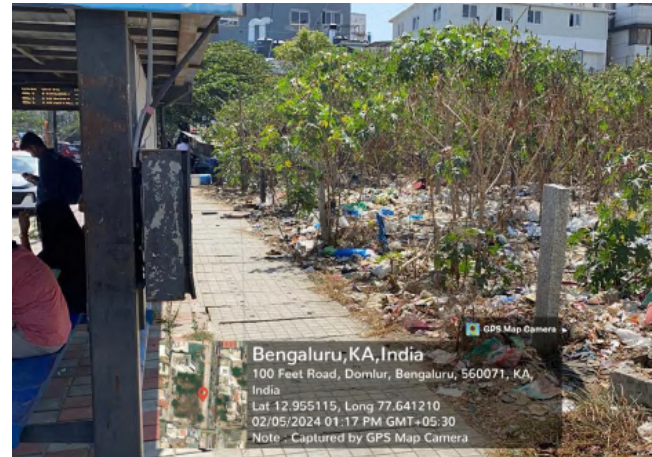
Image: Garbage in empty plot behind.

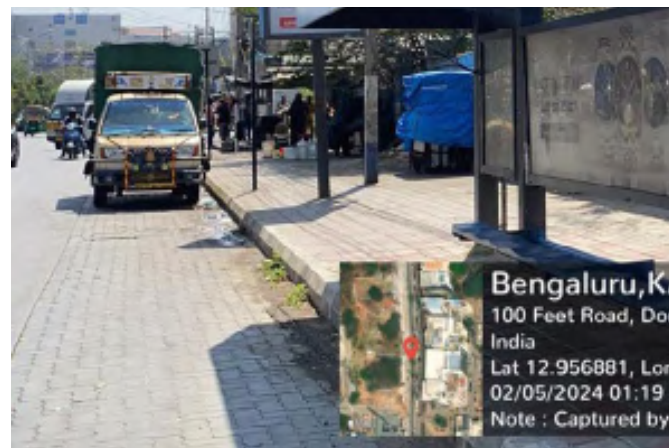
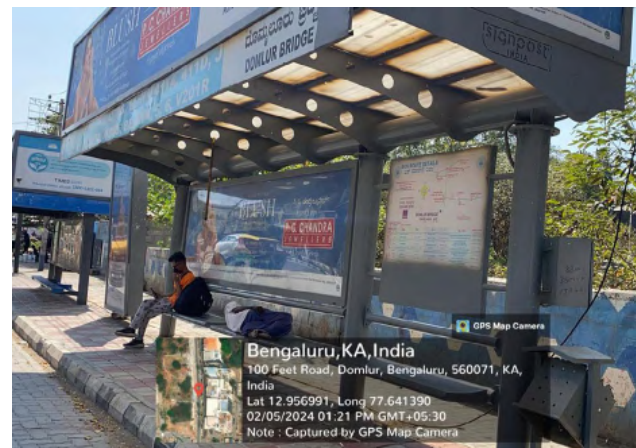
### 13.2.8 Bus Stop: Domlur Bridge (towards Indiranagar)

- There are two shelters for this stop.
- Only one has the name of the bus stop.
- Bus route display is torn up in one of the shelters.
- Apart from that, both of them are in good condition.

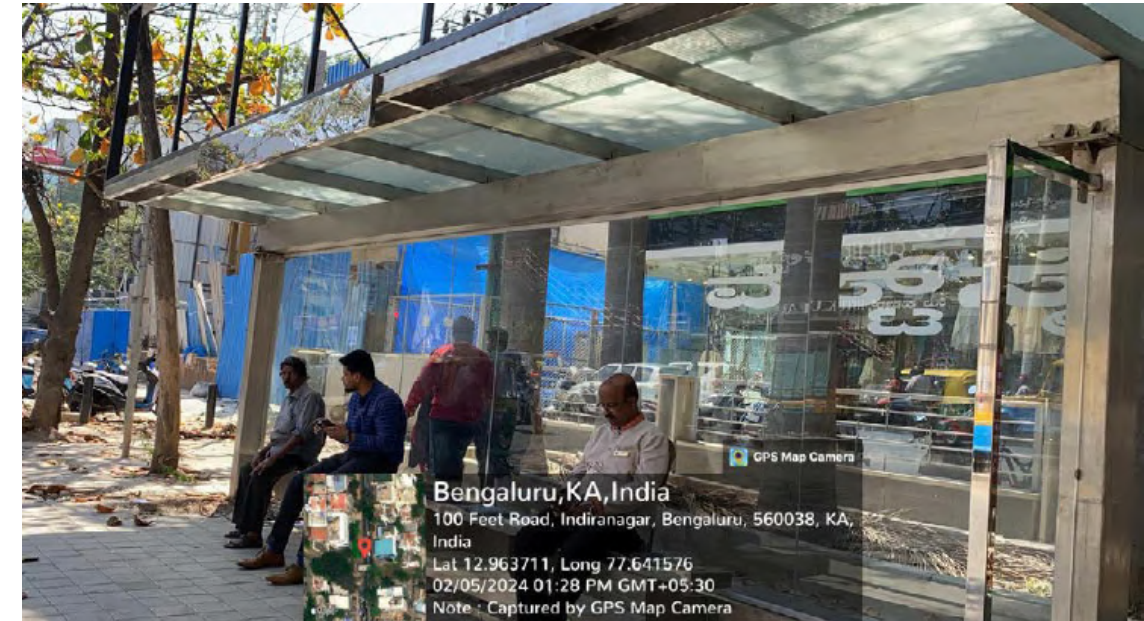
### 13.2.10 Bus Stop: New Horizon (towards Indiranagar)

- Bus route, timings display is missing.
- E-display is present.
- Missing line of tiles close to kerb, broken footpath around column of bus shelter.

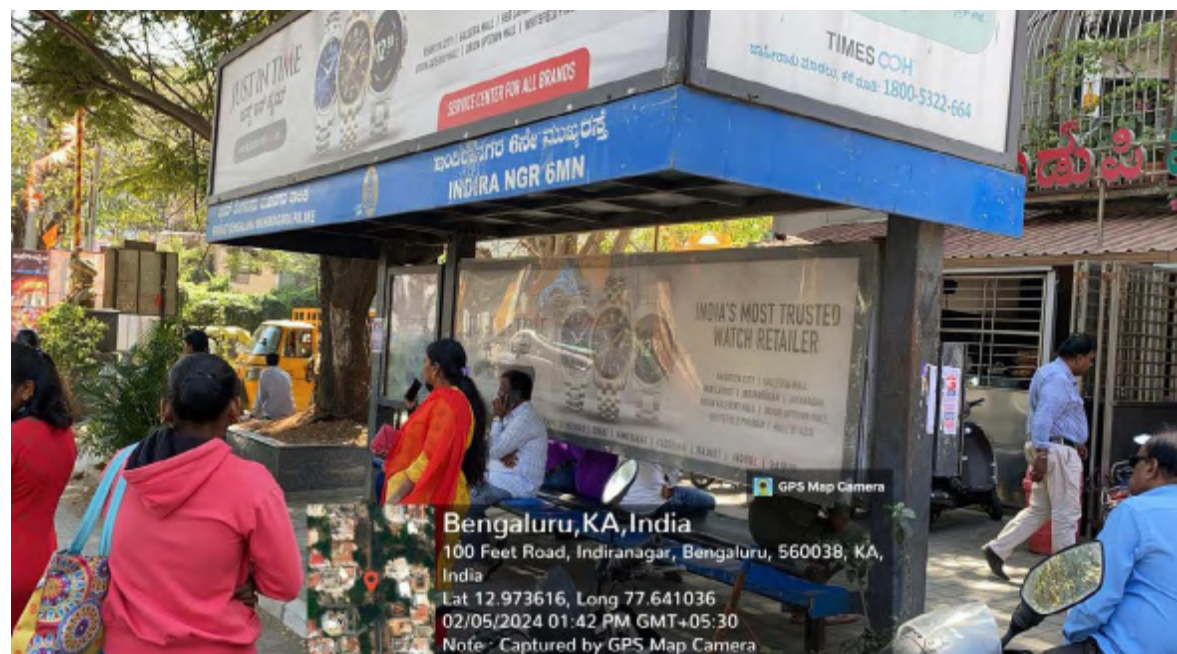
### 13.2.13 Bus Stop: Indiranagar Police Station (towards Indiranagar)

- This bus stop needs some maintenance.
- Footpath-broken
- Name of bus stop/ Signage missing.
- There is some garbage strewn around the bus stop.

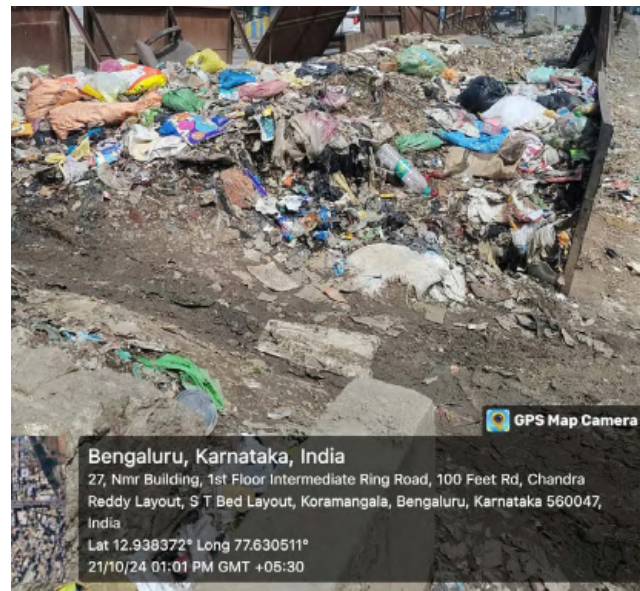
Image: Mountains of plastic disintegrated with soil in the medians.
