IRR Street: Standstill to Active

A Comprehensive & Collaborative Approach to Sustainable Mobility

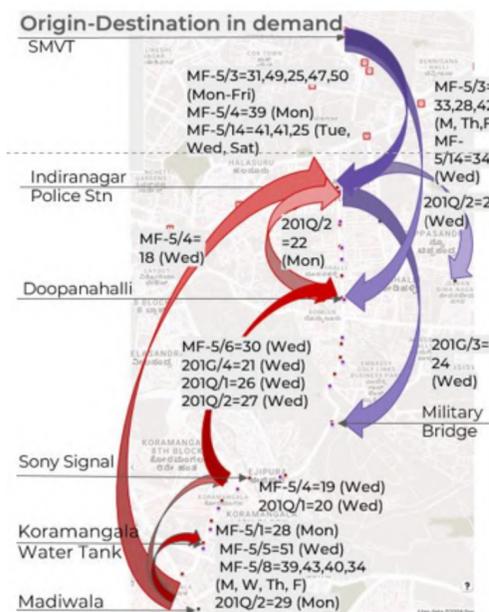
8-9am Hourly Origin-destination demand mapped.

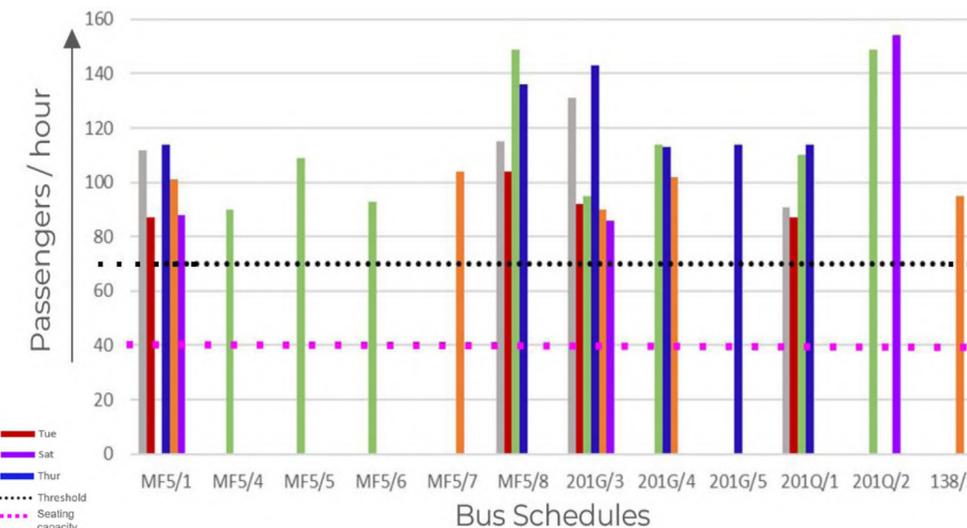
Passengers/ bus towards Indiranagar at 8- 9am in a typical week. Over 140 passengers approx. in some buses at peak hours.

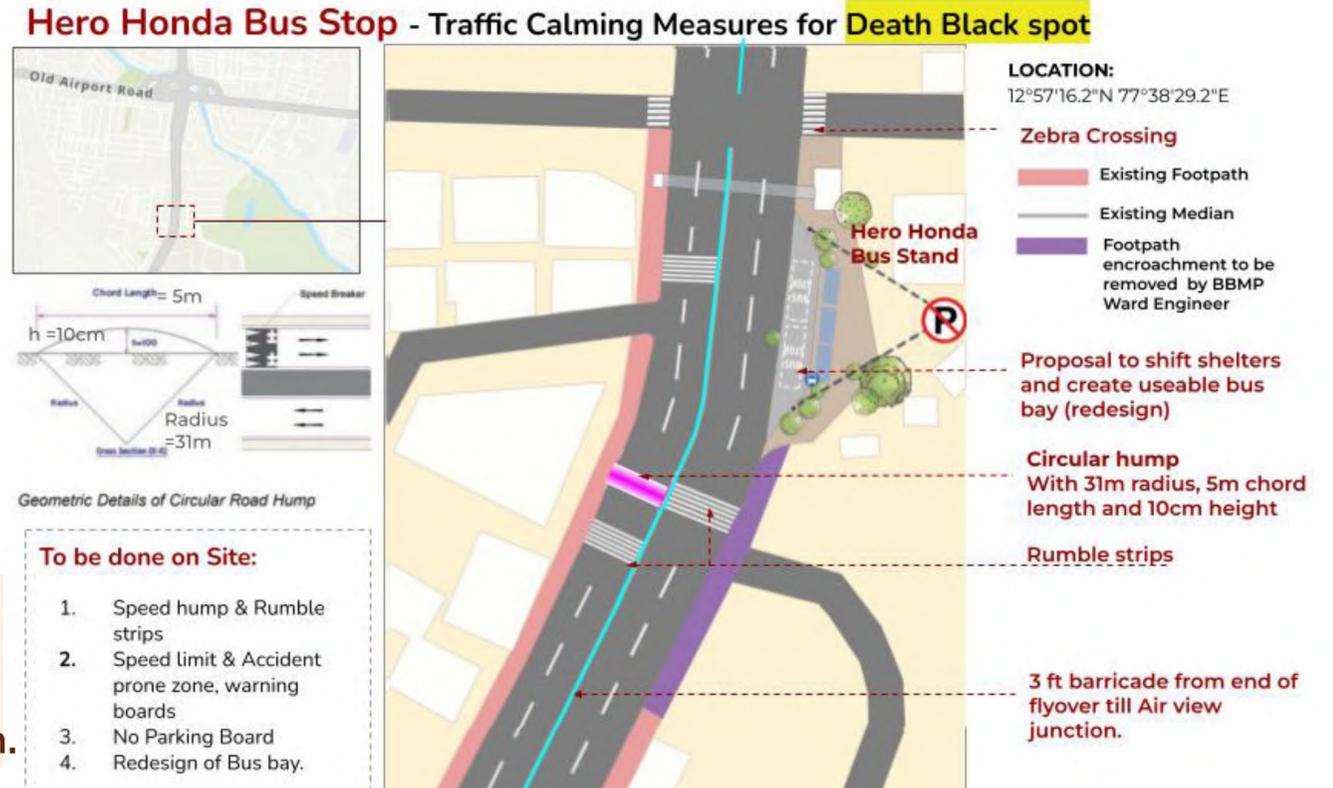
19 Drawings of road markings & traffic calming interventions provided for junctions and blackspots

10 Rumble strips executed at Indiranagar 14th main, 15th main, Domlur flyover ramp down, DELL office & at S curve defence land.

2 Speedhumps and its signage executed

2 HRPCs (raised pedestrian crossings) executed on both sides

2 Zebra crossings laid: at Ejipura junction and relaying at Indiranagar KFC junction

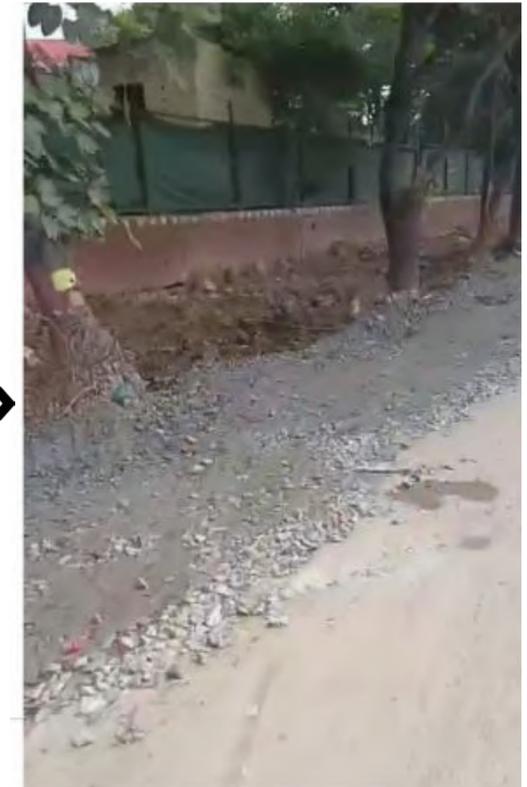
Koramangala water tank bus stop (towards Koramangala) - broken footpath and open drain.

Implementation of a temporary walkway and 10 temporary lights near Ejjipura bus stop towards Indiranagar, after our persistent advocacy.

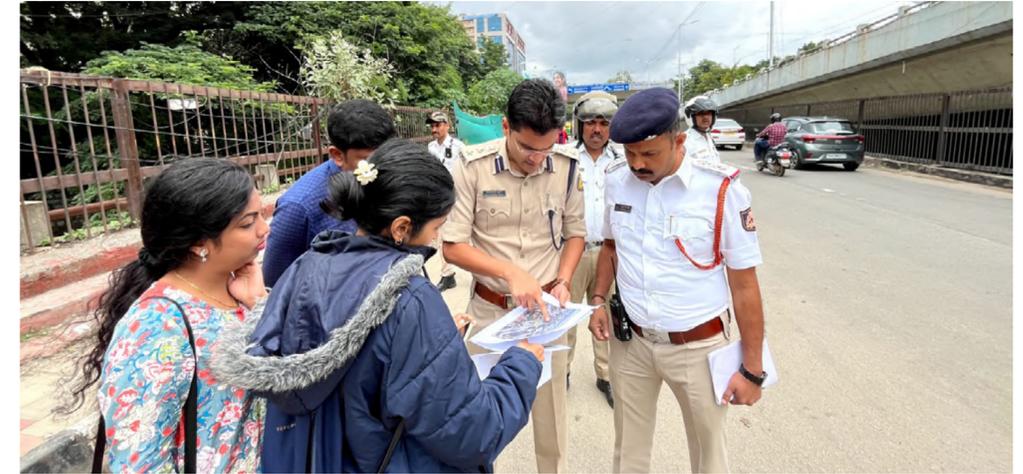
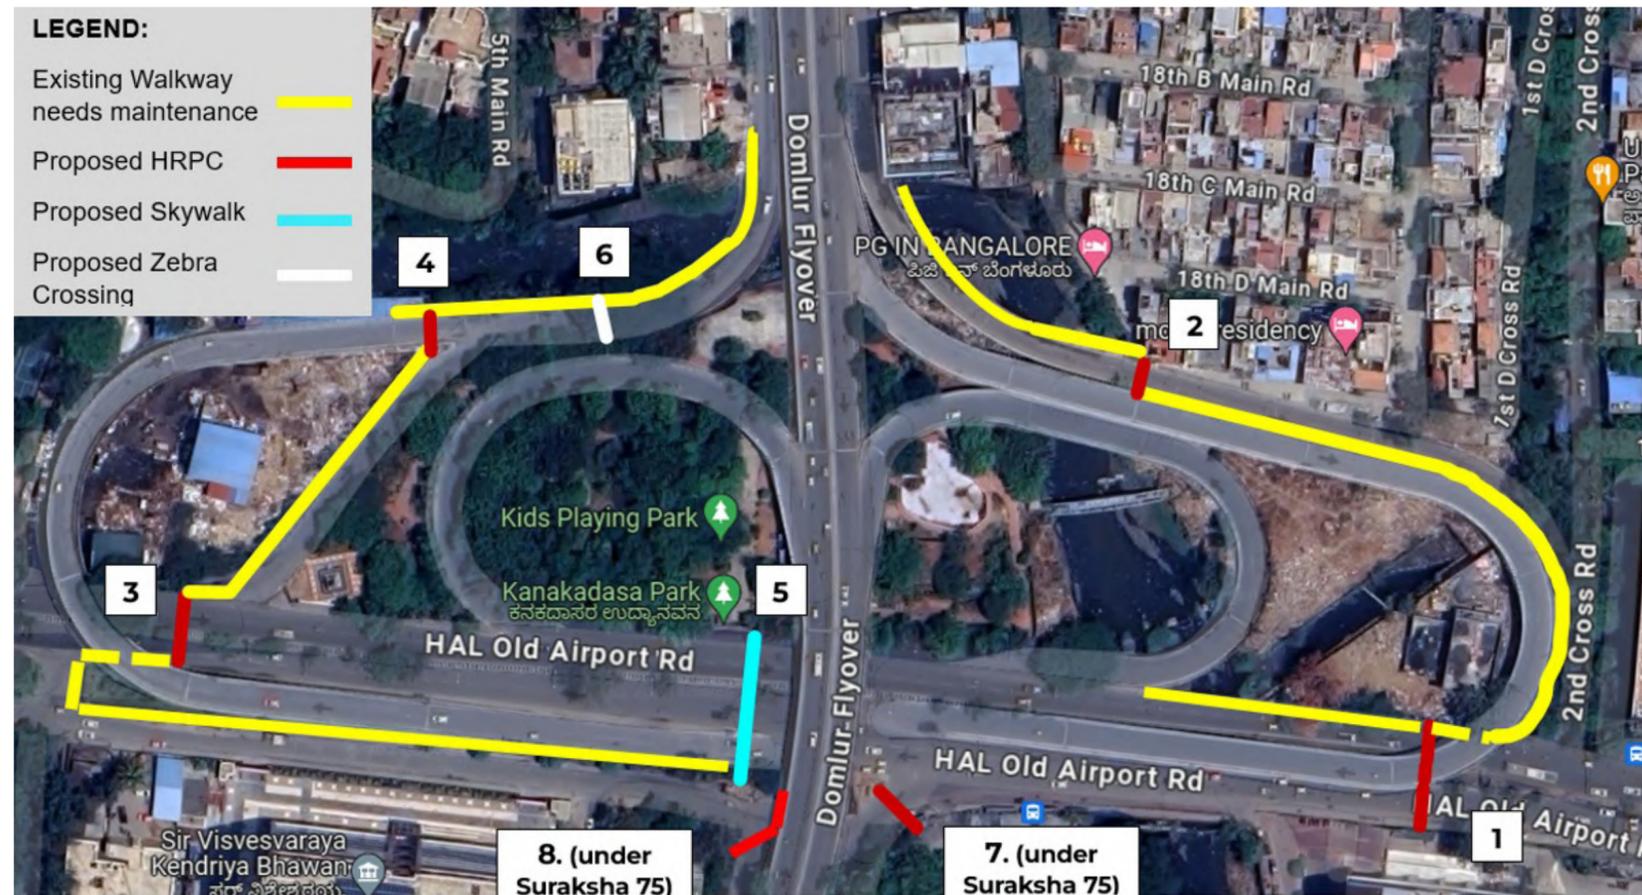
Pedestrian access proposal -key map.

The Domlur Flyover was constructed to streamline traffic, but unfortunately has not considered any accessibility for pedestrians. Footpaths along the flyover are not maintained and remain disconnected, making it exceedingly difficult for pedestrians. They end up crossing busy roads with fast-moving vehicles, risking their safety.

To improve safety and accessibility, we have proposed 6 interventions that will help utilise existing pedestrian infrastructure along the flyover and create new ones for safe pedestrian access. 2 other interventions will be taken up under Suraksha 75.

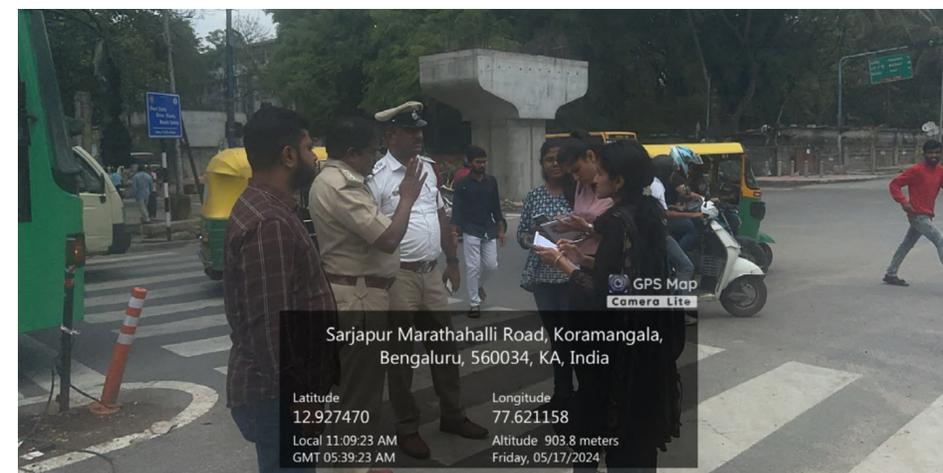
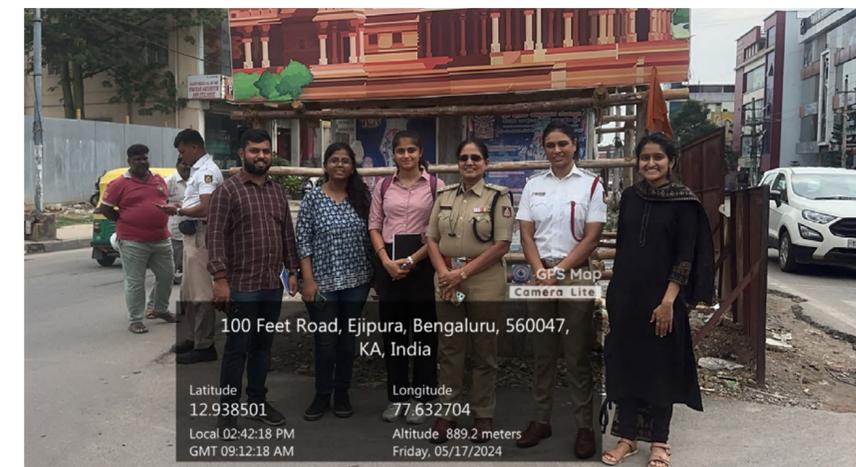
Recommendation for signal modification at Ejipura Junction

For Ejipura Signal and Sony World signal, vehicle count with respect to signal cycle and signal timing for pedestrians were observed., and recommendations shared.

- ↑ Vehicles waiting at red signal
 - ↑ Vehicles moving at green signal
 - | A thin barricade to stop spillover to opposite lane.
- North ←
- *20 sec is indicative only. Time to be determined by BTP.
